APPENDIX NINE

PRELIMINARY SITE INVESTIGATION

Former Shelly Bay RNZAF Base, Shelly Bay Road, Wellington

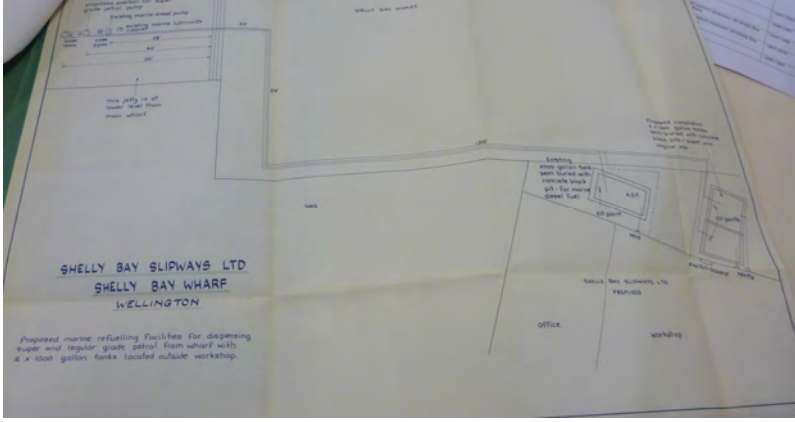
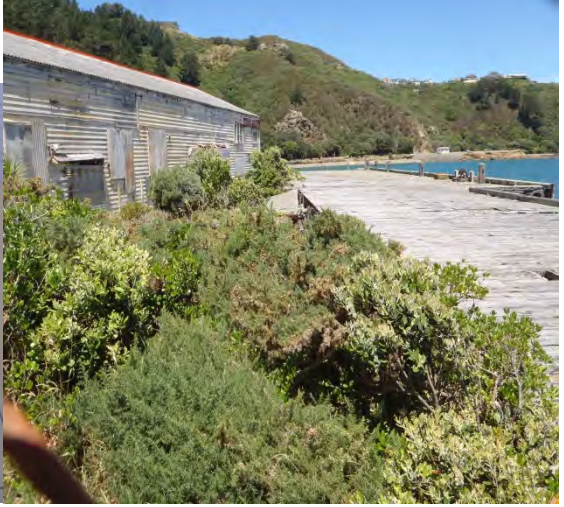
<p>Geotechnical Investigation (Photograph)</p> <p>Plan: Shelly Bay Slipways Limited Shelly Bay Wharf Wellington – Proposed marine refuelling facilities</p> <p>Letter from GI Cooper and WS Brambley Trustees for a Company being formed to be known as Shelly Bay Slipways Limited: Application for a Motors Spirits Retailers Licence Restricted to Marine Craft Only at Shelly Bay Wharf Wellington.</p>	<p>Wellington City Council records show the presence of an existing 2,000 gallon semi-buried diesel storage tank present in a concrete block bund. The document also includes an application dated 16 November 1971 for the installation of 2 semi-buried 1000 gallon super and regular motor spirits tanks.</p> <p>No direct records are available to confirm if the removal of the “existing” tank or whether the proposed tanks were installed.</p> <p>A fax from Wellington Regional Council to the New Zealand Defence Force dated 9 February 1998 states that the site contained underground storage tanks which have now been removed. It is not clear if the tanks removed are related to these tanks.</p> <p>Photograph 16: Plan from Wellington City Council archives of the location of the existing and proposed semi-buried tanks.</p> <p>Photograph 17: Photograph of the approximate area where the semi-buried tanks are/were thought to be located.</p> <p>Evaluation of potential for soil and groundwater impact: soil and groundwater may have been impacted due to operational losses.</p>

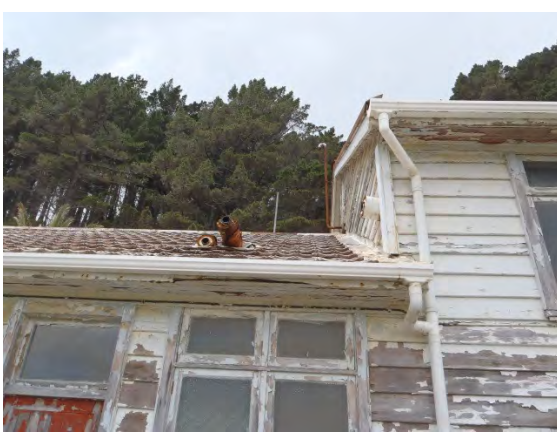
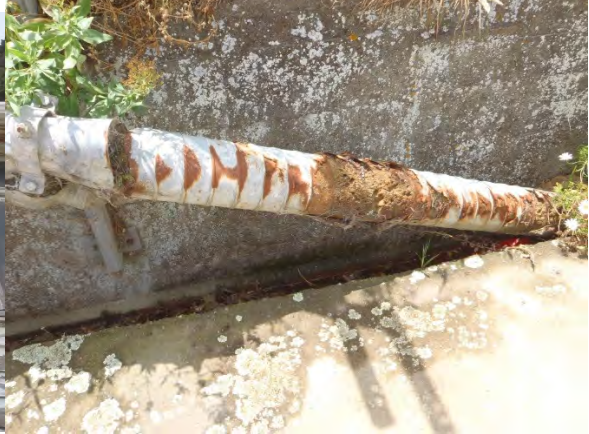
<p>Asbestos</p>	<p>Site Walkover</p>	<p>Asbestos lagging may have been used in piping that transferred heat from the boilerhouse to the buildings at the base. The piping remains present at the site with sections showing various stages of aging/decay exposing lagging.</p> <p>Testing of the lagging material and an asbestos survey have not been undertaken as part of these works.</p> <p>Photograph 18: Pipping and lagging exiting the boilerhouse roof.</p> <p>Photograph 19: Pipe lagging exposed at the base of the greywacke escarpment (North Bay).</p> <p>Evaluation of potential for soil and groundwater impact: An asbestos survey has not been completed for the site. There is potential for the structures already demolished to impact soil if the asbestos was not removed appropriately. If structures or the lagging is to be removed at the site there is potential for soil to be impacted by asbestos if not undertaken correctly. Groundwater is unlikely to be affected by asbestos.</p>

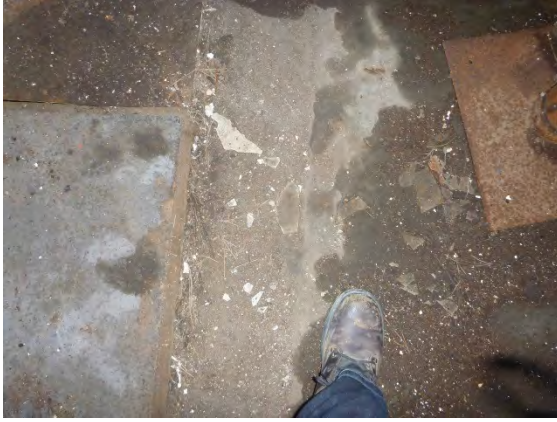
<p>Site Walkover</p>	<p>Possible asbestos containing material present on the floor of the boilerhouse.</p> <p>Photograph 20: Possible asbestos containing material noted on the floor of the boilerhouse.</p> <p>Evaluation of potential for soil and groundwater impact: An asbestos survey has not been completed for the site. There is potential for the structures already demolished to impact soil if the asbestos was not removed appropriately. If structures are to be removed at the site there is potential for soil to be impacted by asbestos if not undertaken correctly. Groundwater is unlikely to be affected by asbestos.</p>

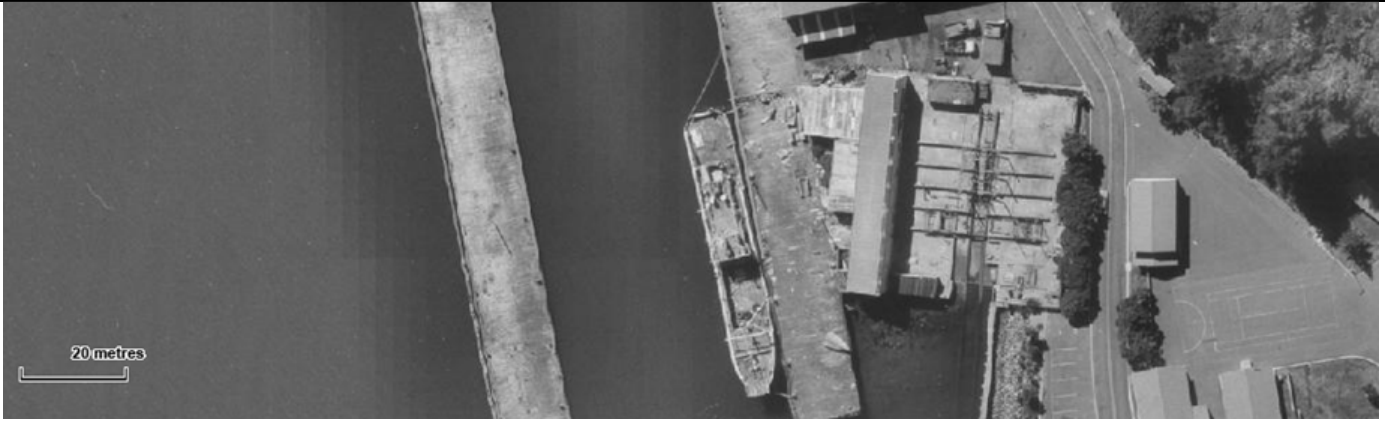
<p>Wellington City Archives</p> <p>Email to Wellington City Council from Unknown?: Shelly Bay Slipway Building Demolition of Lean-to Structures November 2001.</p> <p>1996 Aerial Photograph – Wellington City Council website http://wellington.govt.nz/webmap/wcmap.html</p>	<p>Council records from 2001 show that asbestos sheeting was present in unauthorised lean-to's in the area of the Slipway. These lean-to's were demolished as they were deemed unsafe in December 2001. The letter indicates that SERCO (the base maintenance operators) were to remove the asbestos appropriately and send material to the closest landfill.</p> <p>Photograph 21: Wellington City Council 1996 aerial photograph showing the presence of the lean-to structures adjacent to the Shipwrights Building.</p> <p>Evaluation of potential for soil and groundwater impact: There is potential for the structures already demolished to impact soil if the asbestos was not removed appropriately. Groundwater is unlikely to be affected by asbestos.</p>

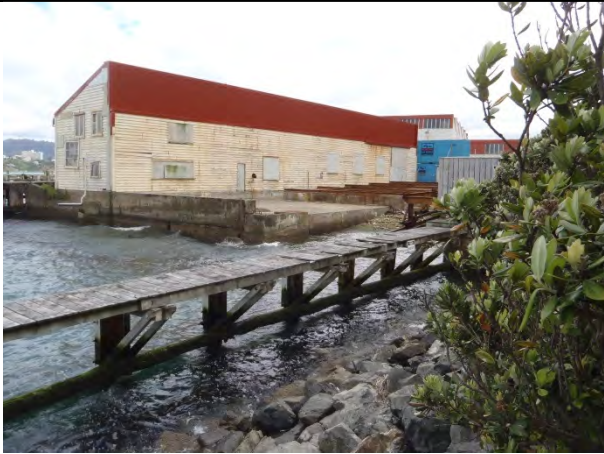
<p>Anecdotal Evidence</p>	<p>AECOM understands that during works undertaken by Tonkin and Taylor in relation to the sea wall in the area of Building No. 8 that asbestos was found in loose and asbestos containing material namely Chrysotile, Amosite and Crocidolite.</p> <p>Evaluation of potential for soil and groundwater impact: There is potential for the asbestos to be present in soil adjacent to the seawall in the area of Building No. 8. Groundwater is unlikely to be affected by asbestos.</p>	<p>No photograph available.</p>
	<p>Opus January 2008</p>	<p>Opus report that the interior of Building No. 8/HQ Building and the Laundry Building (adjacent to the Boilerhouse) may have asbestos present in the interior of the building.</p> <p>Opus also report that Super 6 roofing (containing asbestos) may be present on the Shipwrights Building.</p> <p>Photograph 22: Shipwrights Building looking northwest across the Slipway area. It appears that the roof of the structure is newly painted/new. This may have occurred following the Opus January 2008 report.</p> <p>Evaluation of potential for soil and groundwater impact: An asbestos survey has not been completed for the site. There is potential for the structures already demolished to impact soil if the asbestos was not removed appropriately. If structures are to be removed at the site there is potential for soil to be impacted by asbestos if not undertaken correctly. Groundwater is unlikely to be affected by asbestos.</p>

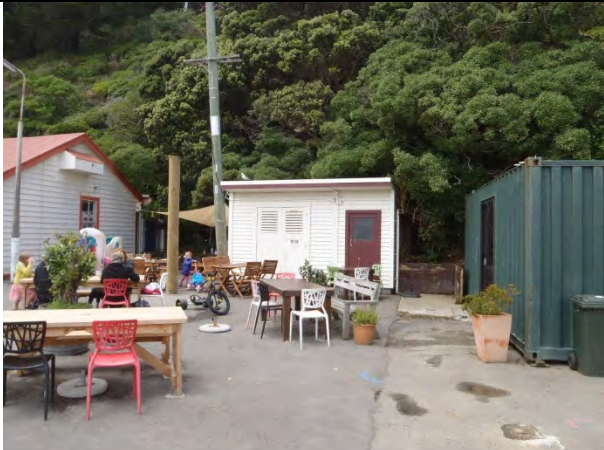
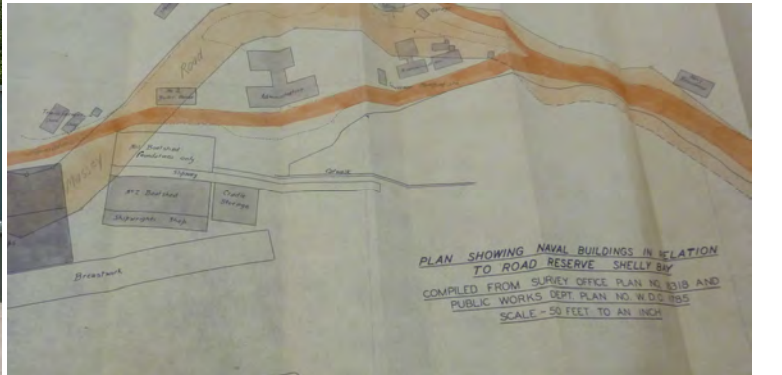
<p>Transformer/PCB's</p>	<p>Current Transformer Location: Site Walkover</p> <p>Historical Transformer Location: Plan Showing Naval Buildings in Relation to the Road Reserve Shelly Bay (Compiled from Survey Office Plan No. 18318 and Public Works Dept Plan No. W.D.O 1785). Pencil date</p>	<p>Two transformer locations were noted at the site, one historical transformer located to the east of the slipway adjacent to the library and one located adjacent to the current café.</p> <p>Photograph 23: Current transformer location in the area of the café.</p> <p>Photograph 24: Snapshot of the plan showing the historical transformer location.</p> <p>Evaluation of potential for soil and groundwater impact: The transformers may have previously contained oils with polychlorinated biphenyls (PCB). No visual or olfactory evidence of staining was observed around the current transformer. There may be so localised impact around the transformer locations.</p>

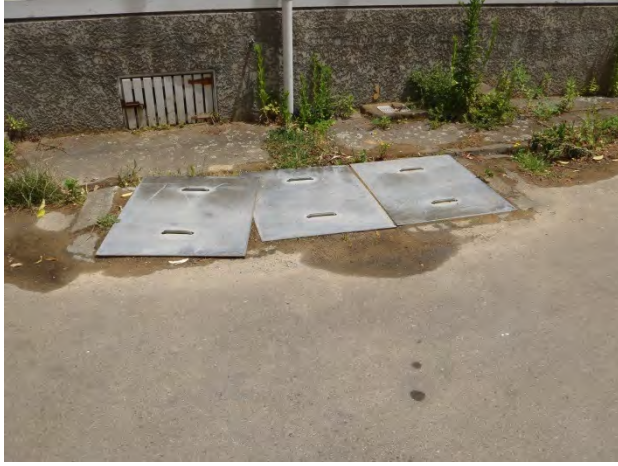
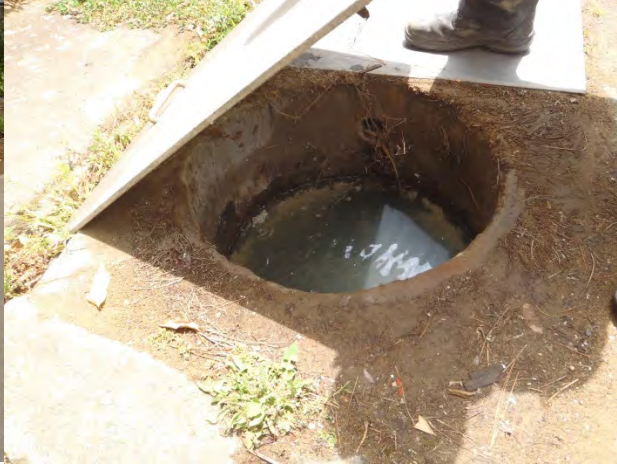
<p>Liquid Waste</p>	<p>Site Walkover Opus January 2008</p>	<p>A fat trap is present at the rear of the combined mess building.</p> <p>Photograph 25: Fat trap at the rear of the combined mess. Photograph 26: Last chamber of the fat trap. Some residual fat remains.</p> <p>Opus January 2008 reports that an area of liquid residue contamination was present on the concrete floor in southwest corner of the Shipwrights Building. Access to this building was restricted during the PSI. No photograph of the staining is available.</p> <p>Evaluation of potential for soil and groundwater impact: Significant impact to soil or groundwater is not expected related to the fat trap. The origin of the liquid residue “contamination” noted in the Opus January 2008 report is unknown, therefore the impact on soil and groundwater is unable to be quantified.</p>

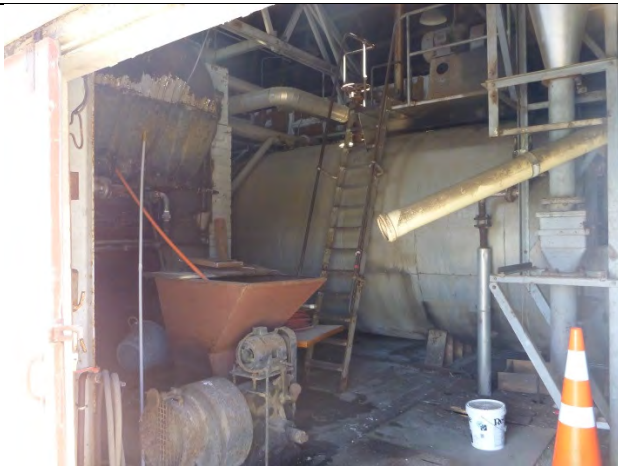
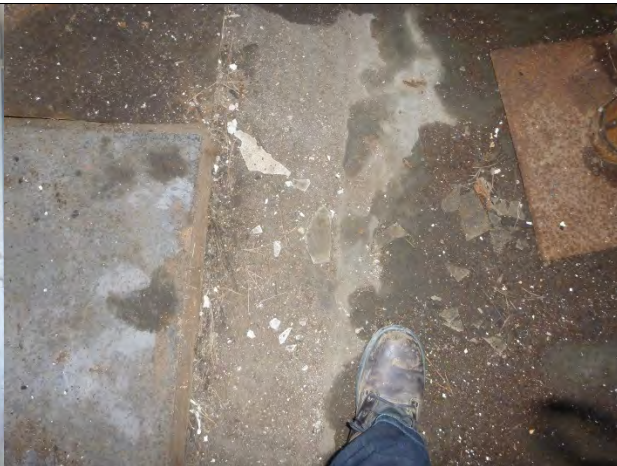
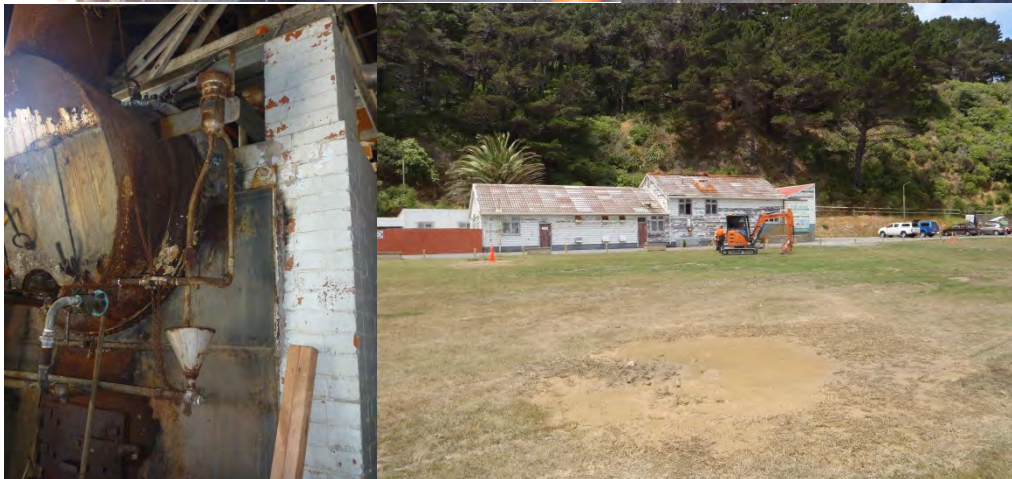
<p>Boilerhouse/Pumphouses</p>	<p>Site Walkover</p>	<p>A coal fired boilerhouse is present in the north bay. There was no evidence in either Wellington City Archives or during the Site Walkover of boiler ash at the site.</p> <p>Minor hydrocarbon staining noted on the floor of the main boilerhouse room.</p> <p>Photograph 27: Boilerhouse interior taken from the main door. Photograph 28: Hydrocarbon staining on the main boilerhouse room floor. Photograph 29: Boilerhouse fireplace. Photograph 30: Boilerhouse and Laundry looking east over the former Airman's accommodation.</p> <p>Evaluation of potential for soil and groundwater impact: Soil and groundwater impact may be present related to the burning of coal to fire the boiler and hydrocarbon staining on the concrete. No evidence of ash burial was found in records relating to the site or during the site walkover. Significant impact related to the operation of the boilerhouse is considered unlikely.</p>

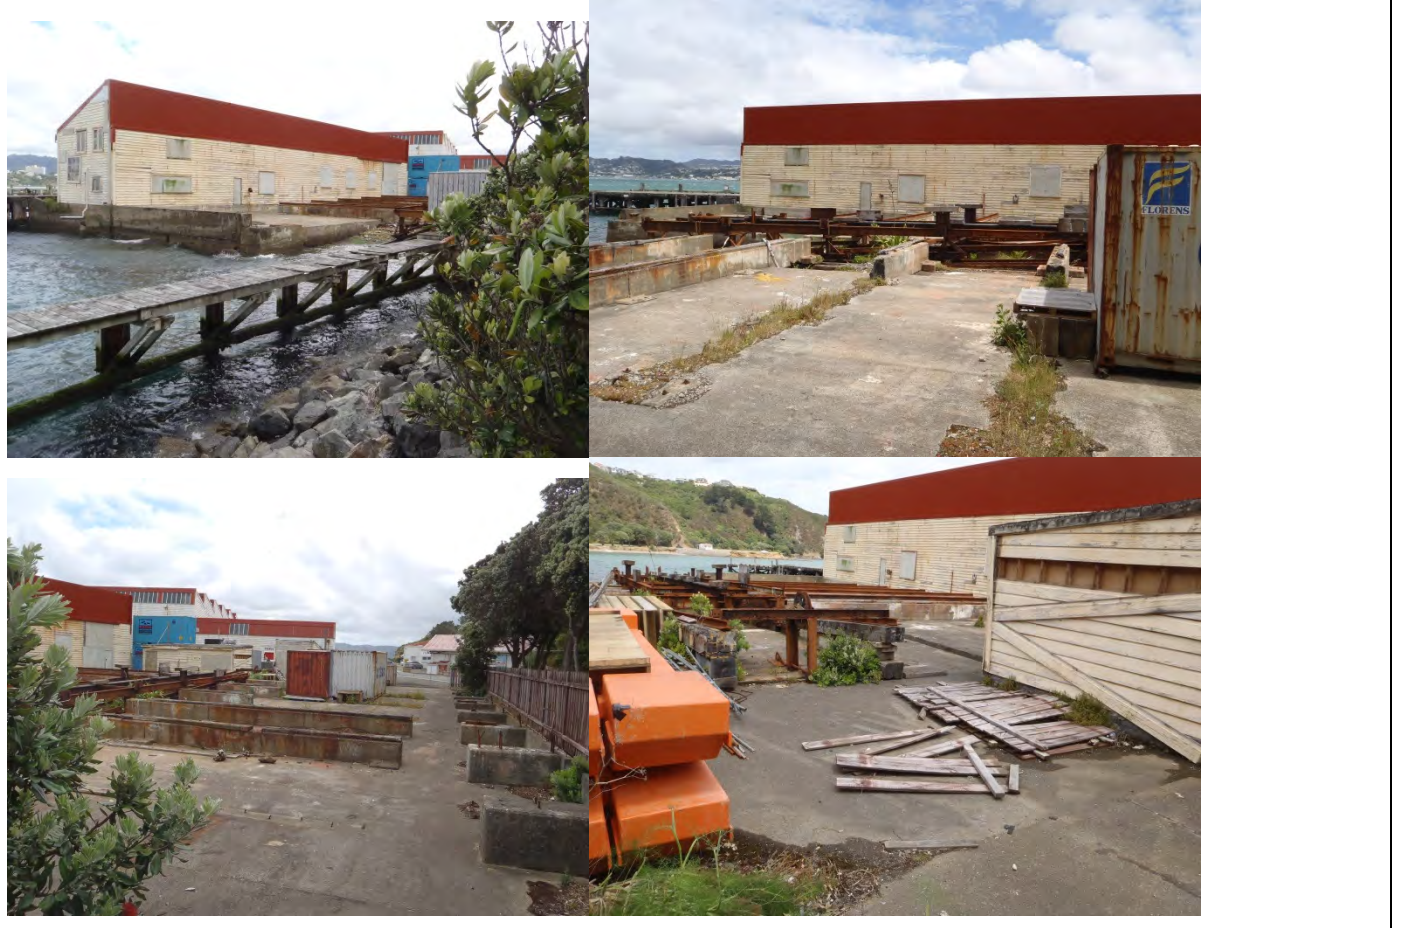
<p>Slipway</p>	<p>Site walkover</p> <p>Evening Post Article: the slipping of Shelly Bay.</p> <p>Opus January 2008</p>	<p>The facility was not observed as part of the PSI. Photographs were taken from outside the fenced area.</p> <p>Article notes: Ex-wartime launches used as civil aviation control craft for the flying boat base in Evans Bay and also finishing boats, pleasure craft and coasters that needed repairing were serviced at the Shelly Bay Slipway.</p> <p>Activities at the slipway have included the recovery of scrap metal, vehicle repair and trailer fabrication.</p> <p>Sediments may contain elevated levels of metals and hydrocarbons from industries undertaken in the area.</p> <p>Photograph 36: Slipway and finger pier taken from Shelly Bay Road. Photograph 37: Slipway concrete area looking southwest taken from Shelly Bay Road. Photograph 38: Slipway concrete area looking north taken from Shelly Bay Road. Photograph 39: Slipway cradle area looking south taken from Shelly Bay Road.</p> <p><i>Evaluation of potential for soil and groundwater impact:</i> Based on aerial photographs it appears that the working areas of the slipway have been concreted. It is therefore considered that localised impact to soil and groundwater may have occurred in localised area (such as the crane hydraulic fluids (if used)).</p> <p>If dredging of the slipway area is required for the development, sediment may be impacted and require specialist disposal.</p>

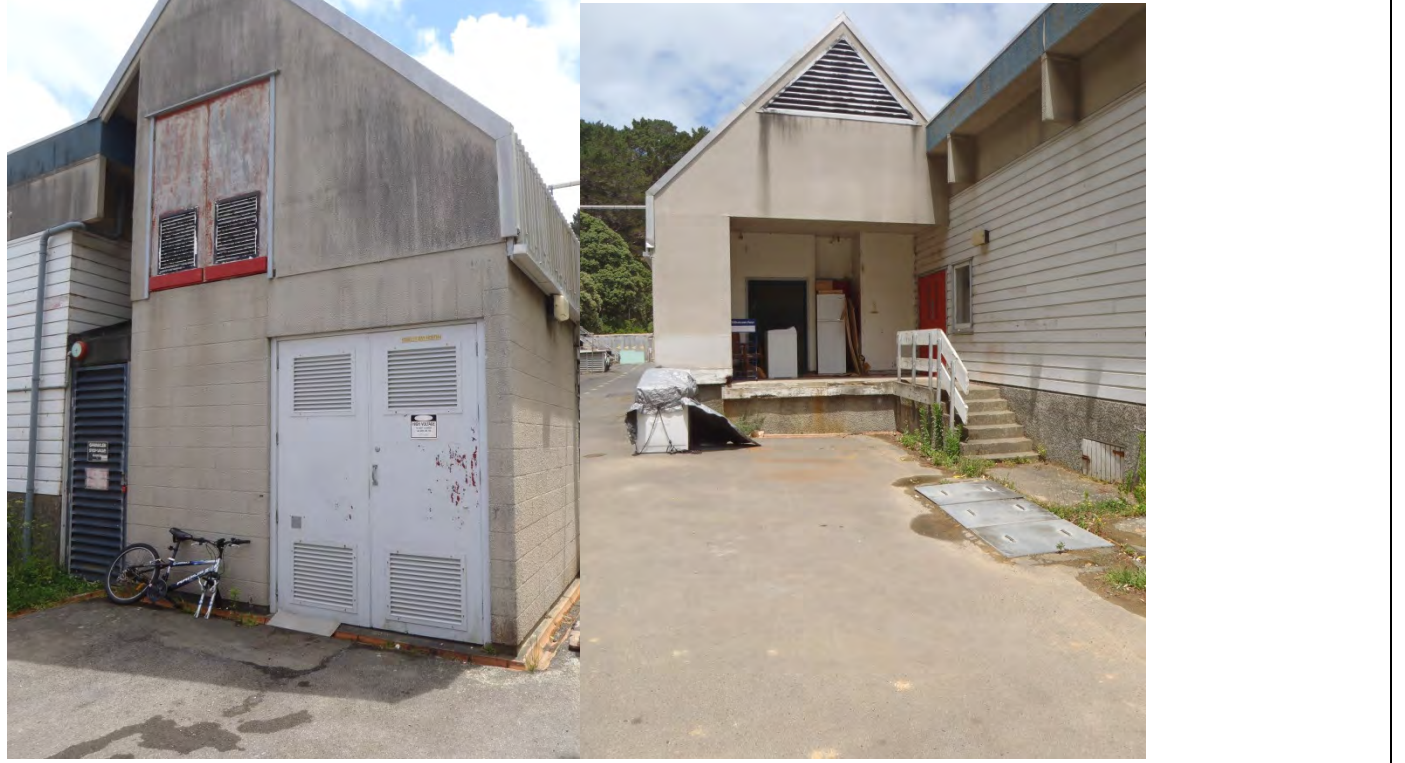
<p>Generator/Refrigeration?</p>	<p>Site Walkover</p>	<p>Generator/Refrigerator present at the rear (east) of the mess facility in North Bay.</p> <p>Photograph 40: Southern exposure of the gas/refrigeration plant at the mess facility. Photograph 41: Northern exposure of the gas/refrigeration plant at the mess facility.</p> <p><i>Evaluation of potential for soil and groundwater impact:</i> No significant impact expected.</p>

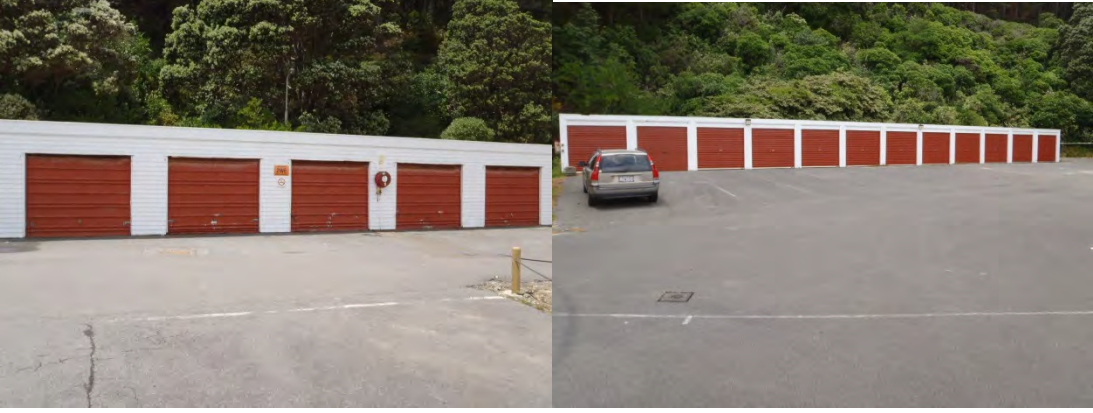
<p>Garaging</p>	<p>Site Walkover</p>	<p>Vehicle garages are located on the eastern boundary of North Bay and the northeast boundary of South Bay.</p> <p>Photograph 42: North Bay garaging. Photograph 43: South Bay garaging</p> <p><i>Evaluation of potential for soil and groundwater impact:</i> No significant impact expected.</p>

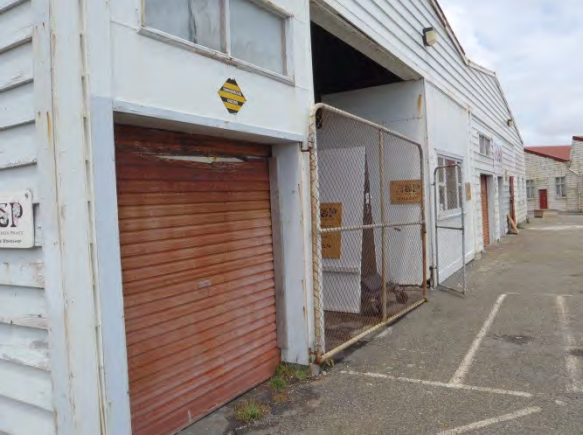
<p>Serco Paint Store</p>	<p>Site Walkover</p>	<p>The Serco Paint Store and Workshop is located directly to the east of Building 8.</p> <p>The facility was not inspected as part of the PSI, however it is expected that vehicle maintenance and the storage of paint was undertaken in this building.</p> <p>Photograph 44: Serco workshop facility.</p> <p><i>Evaluation of potential for soil and groundwater impact:</i> No significant impact expected.</p>
