Annual coastal monitoring report for the Wellington region, 2008/09

Juliet R Milne

Environmental Monitoring and Investigations Department

GW/EMI-G-09/236

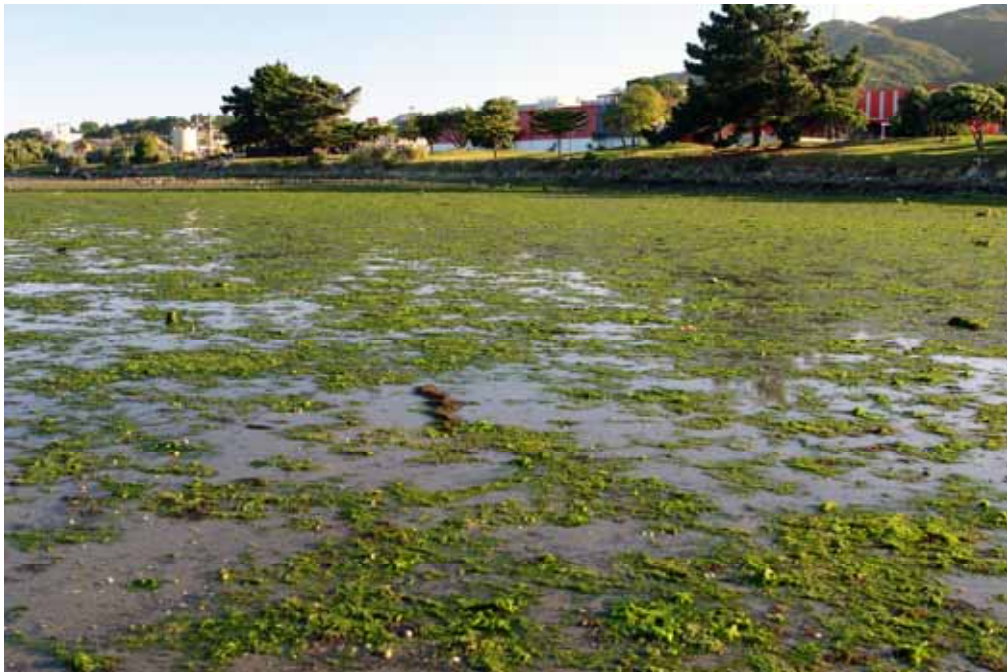
Figure 5.2: Dense cover of sea lettuce (*Ulva* sp.) in the Onepoto Arm of Porirua Harbour

- *Eutrophication*: Similar to last year's findings, sediment nutrient concentrations and the depth of the oxygenated surface sediment layer indicate that both arms of the harbour are moderately eutrophic or enriched. This conclusion is supported by the presence of elevated numbers of benthic fauna that tolerate moderate levels of mud and/or organic enrichment, and the widespread coverage of macroalgae. More than 10% of the intertidal habitat in the Pauatahanui Arm, and more than 30% of the intertidal habitat in the Onepoto Arm had greater than 50% coverage of macroalgae (Figure 5.2), resulting in localised nuisance conditions (rotting macroalgae and poorly oxygenated and sulphide-rich sediments). At this stage, enrichment is not a major problem, but there is a need for caution in relation to factors that could increase nutrient concentrations and fine sediment in the harbour.

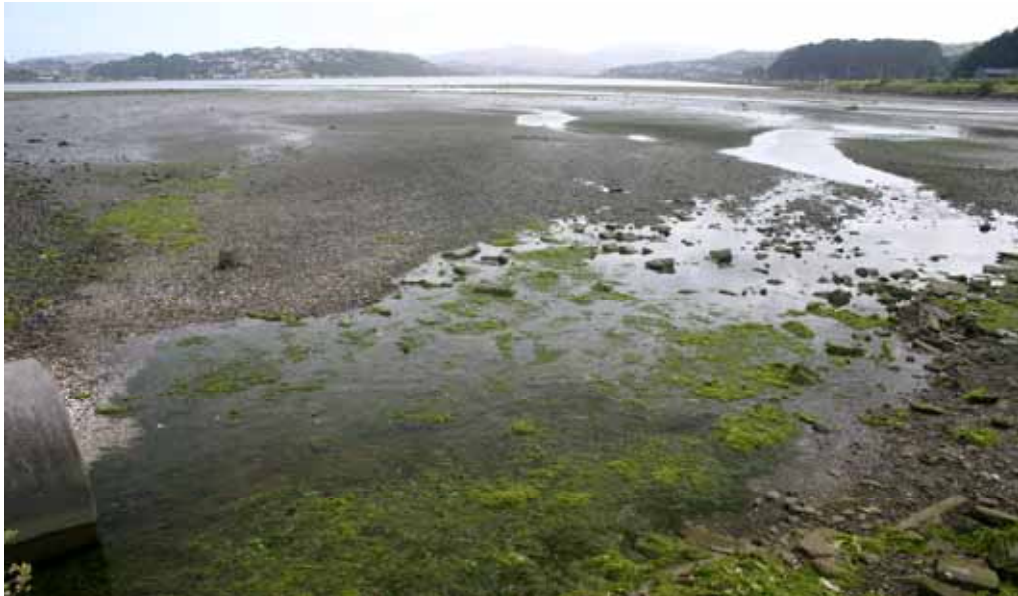
Figure 6.1: Outflow from the Sempole Street stormwater outfall at the southern end of the Onepoto Arm of Porirua Harbour

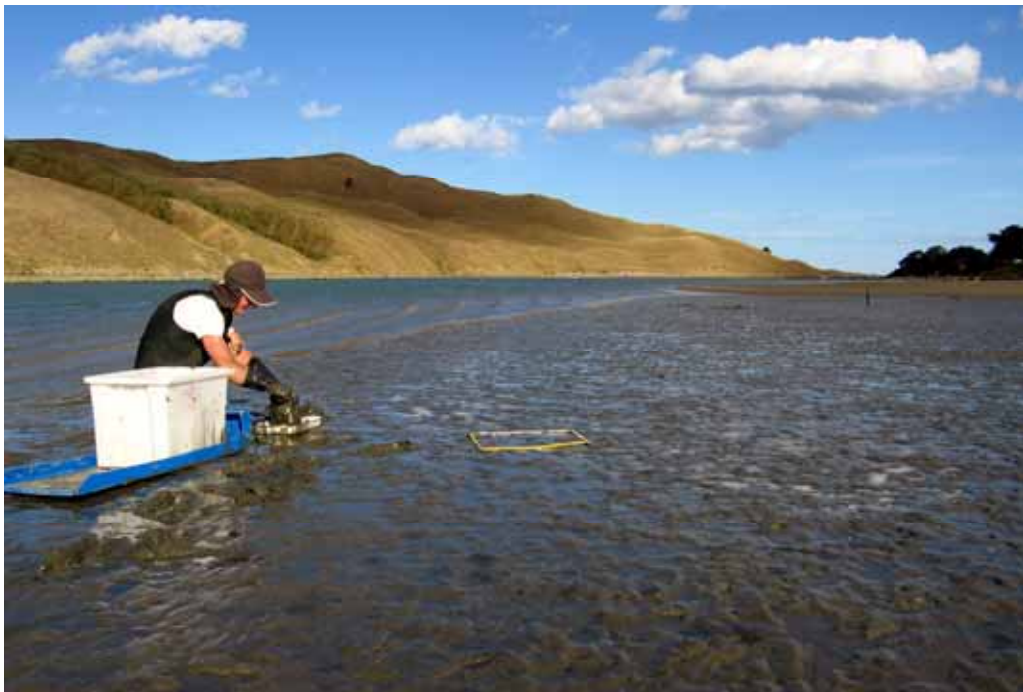
Figure 7.1: Sampling the Whareama Estuary intertidal mudflats in January 2009

Monitoring was undertaken at two sites located on the unvegetated intertidal mudflats (Figure 7.1 & Table A2.4, Appendix 2). This monitoring included assessments of up to 10 plots per site for selected "fine-scale" sediment condition indicators – including grain size (texture), the degree of oxygenation, nutrient and organic content, and heavy metal concentrations – and benthic (sediment-dwelling) fauna abundance and diversity. The fine-scale monitoring methods were based on an extension of the tools included in the National Estuary Monitoring Protocol (Robertson et al. 2002). The depths to four sedimentation monitoring plates deployed at right angles to the Whareama River channel in January 2008 were also measured.

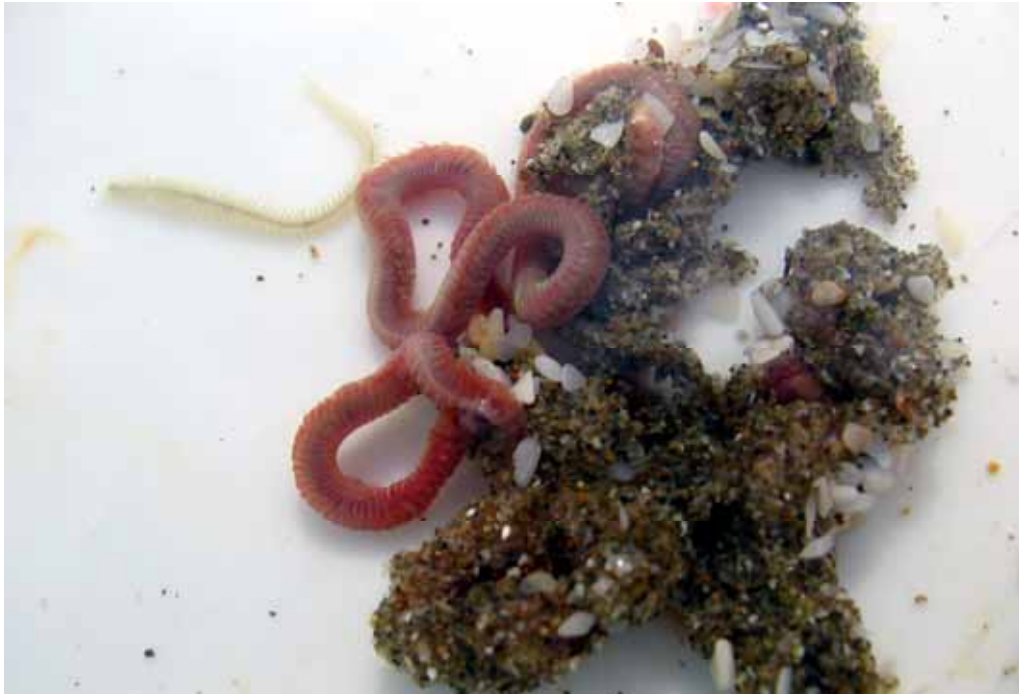
Figure 8.2: Examples of some of the benthic fauna found at Castlepoint Beach in January 2009

Similar to the first survey (undertaken in January 2008), the results for the selected physical and biological indicators of beach condition showed that the dominant intertidal habitat was generally in “good” condition. The beach sediments consisted of well-oxygenated sands and support benthic invertebrates that are typical of exposed oligotrophic (nutrient-poor) beach environments, such as isopods, amphipods, beetles and polychaete worms (Figure 8.2).
