Te Awarua-o-Porirua Harbour Sediment Plate Monitoring 2023/2024

Report prepared for Greater Wellington by Salt Ecology

Stevens LM, Rabel H. 2024. Te Awarua-o-Porirua Harbour Sediment Plate Monitoring 2023/2024. Salt Ecology Report 136, prepared for Greater Wellington Regional Council, July 2024. 22p.

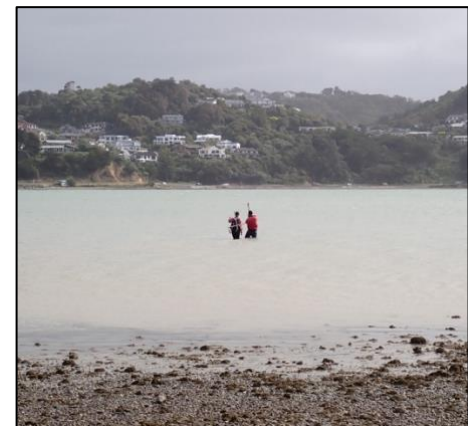
Turbid water above subtidal mud at Ration Point.

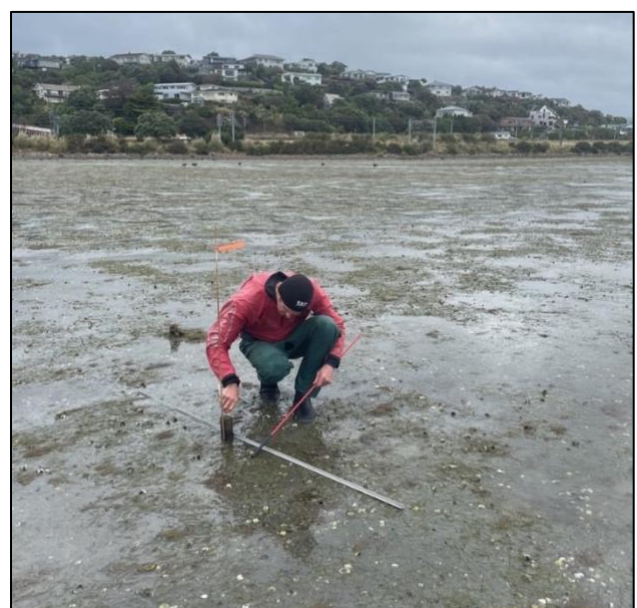
Measuring sedimentation at Site O1 (Onep A), Onepoto Inlet, December 2023.

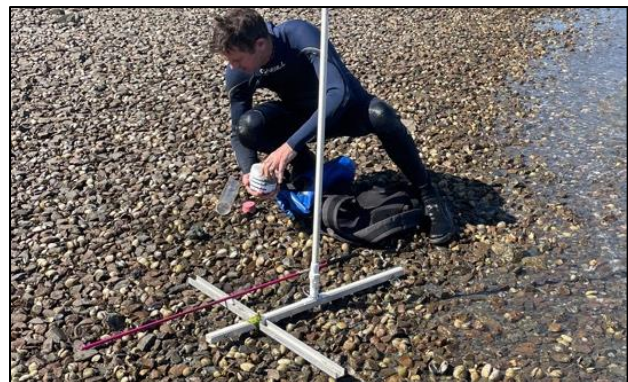
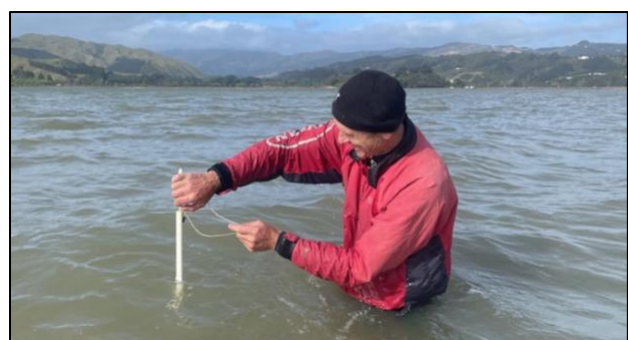
Subtidal plate depths were measured using a custom-built frame (see photo below). The frame was positioned ~ 5 cm above the sediment overlying each relocated plate and allowed to settle onto the surface sediment. A measuring rod was then pushed down through a vertical tube to the underlying plate. Sediment depth is the distance between the base of the frame and the buried plate.

The measurement is taken above the water surface using marked increments on the measuring rod. To collect three replicate measures at each plate, the frame was repositioned twice more by carefully lifting, rotating 30° clockwise, and allowing it to resettle. Where walking access is limited a boat or kayak is used to reach some of the subtidal sites.

Frame used to measure subtidal plates (top) and measuring a subtidal plate at the water surface (bottom).

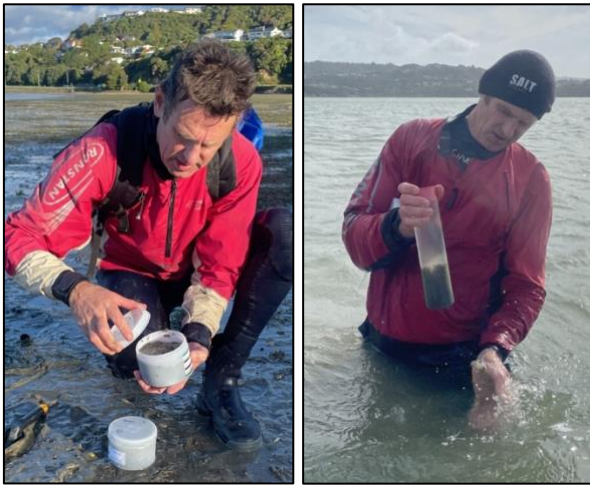
A sample of the surface 20mm of sediment is collected adjacent to each sediment plate and combined to make one composite sample per sediment plate site. Intertidal samples are collected with a trowel, and subtidal samples are collected with a perspex core (see photos below). The samples are analysed for particle grain size (wet sieve, Hill Labs; Appendix 1). This approach allows changes in sediment muddiness to be determined even where there are no changes in sediment depth. Results are compared to condition bands (Table 1) described in Section 2.4.

Collecting sediment samples for laboratory grain size analysis.

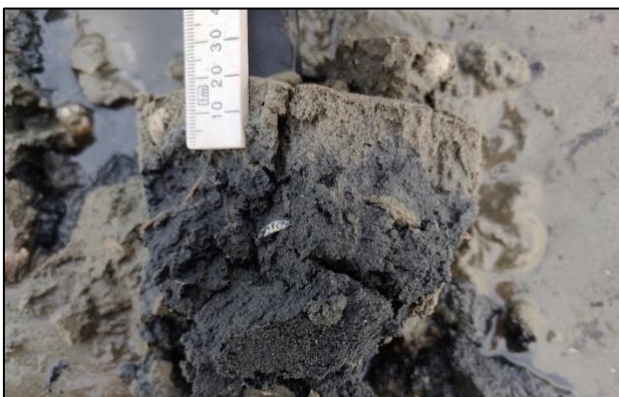
Sediment oxygenation is visually assessed by measuring the depth at which sediments show a change in colour to grey/black, commonly referred to as the apparent Redox Potential Discontinuity (aRPD) depth. Results are compared to condition bands (Table 1) described in Section 2.4.

The depth to a visually obvious colour change is used to assess oxygenation in sediment.

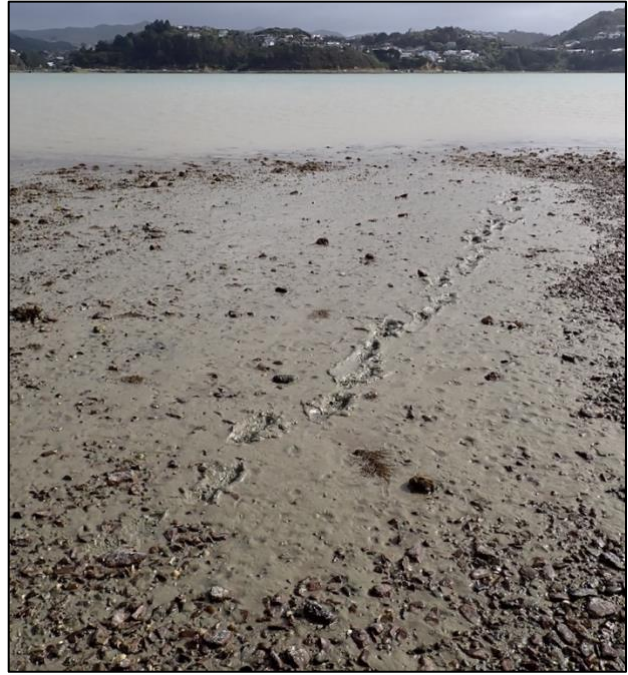
Mud deposited over cobble and gravel substrate along transect PS2 – Horokiri, December 2023.

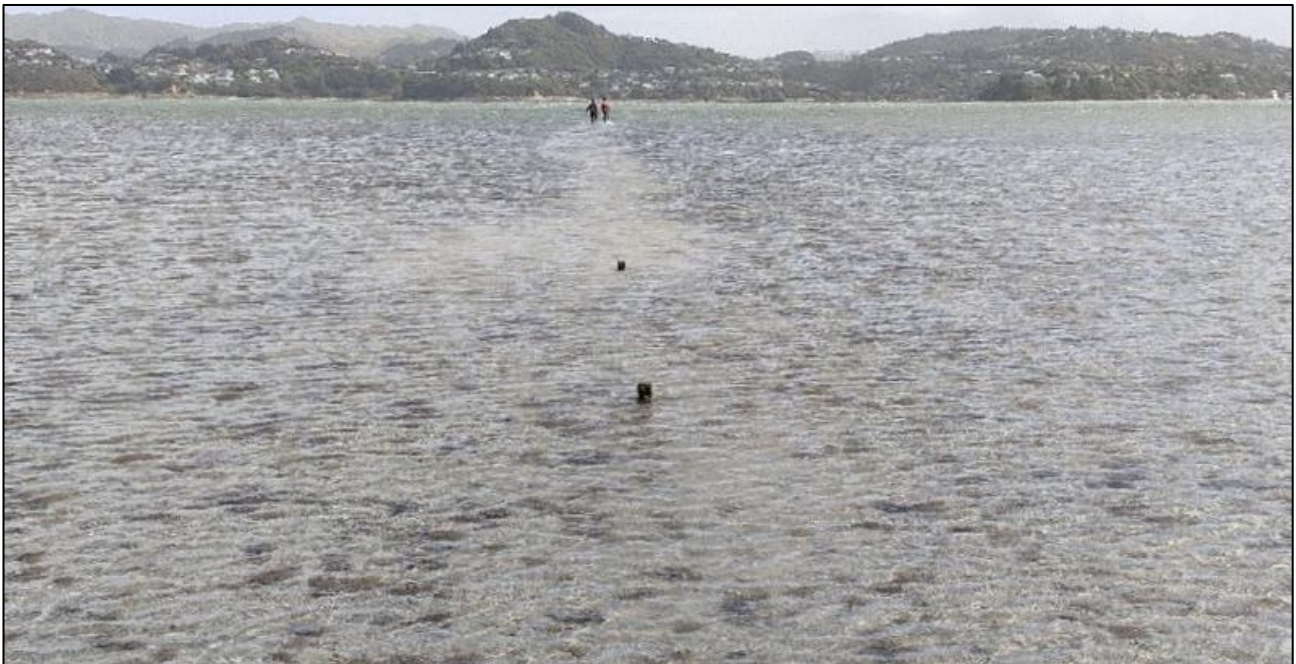
View from Kakaho intertidal site P7 toward subtidal site PS1. Note the plume of resuspended sediment created when wading in shallow water.

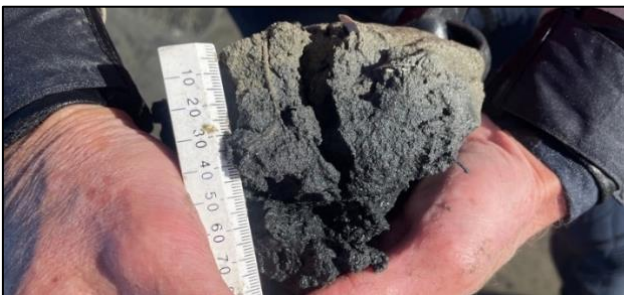
25mm of oxygenated sand above organically enriched sediment Onep B (O3), Onepoto Inlet.

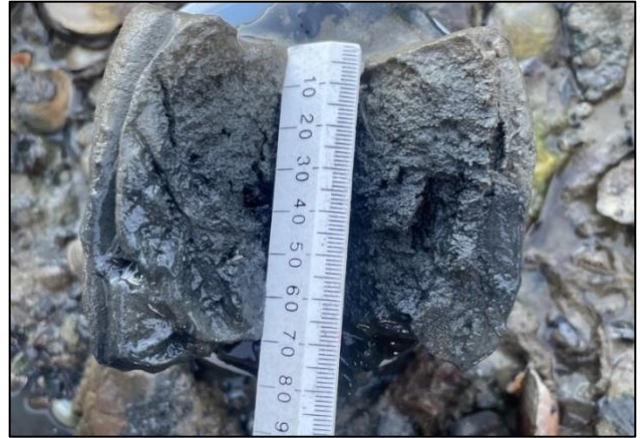
10mm layer of oxygenated sand at site PS3, Pāuatahanui Inlet.

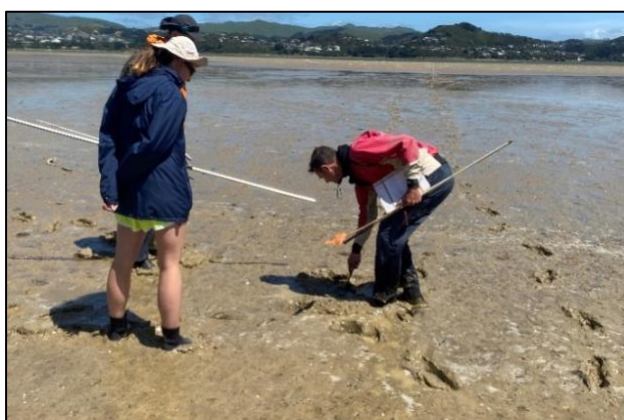
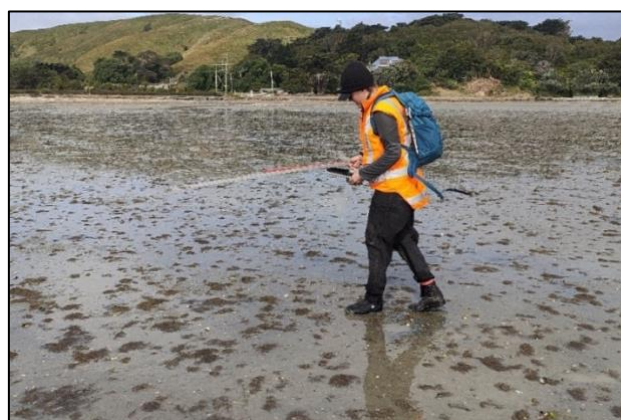
Photos showing the change in muds smothering Pāuatahanui site Kakaho (P7) in December 2020 (left) and December 2023 (right).

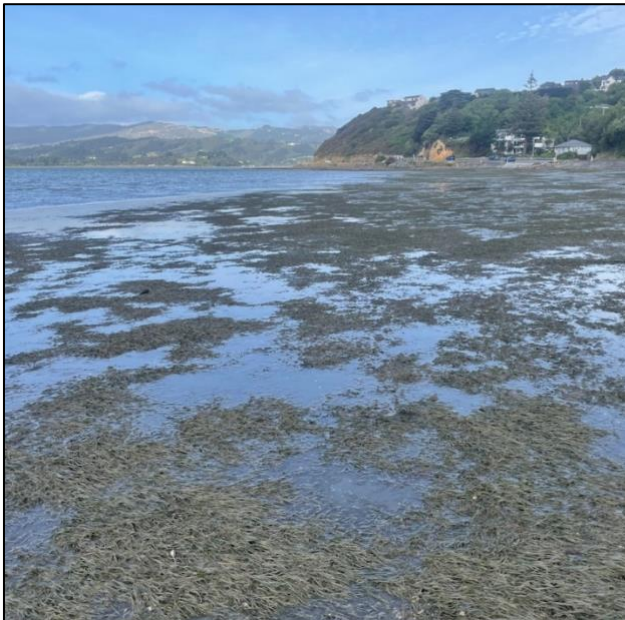
While undertaking the field survey in December 2023, observations were noted on two features in the estuary that are likely to be of interest to GWRC. The first is related to the recovery of seagrass reported in January 2023 as having declined by ~90% at Bradeys Bay in response to impacts attributed to high sediment deposition. Much of this seagrass has now re-established in areas where it was previously growing, although it is still showing signs of extensive epiphytic growth and smothering by filamentous algae (see photos below).

Recovering seagrass in Bradeys Bay, December 2023.

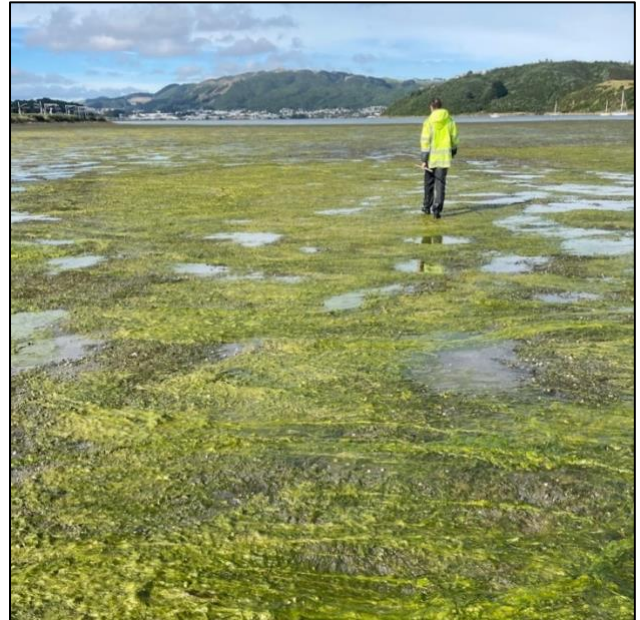
The second observation relates to mats of *Chaetomorpha ligustica* that anecdotally have become more conspicuous in recent years (Stevens and Forrest 2020), and appear to be the same species described as being present in Te Awarua-o-Porirua Harbour since the 1950's (Adams 1994). The extensive drift (unattached) mats observed on the Paremata railway flats in January 2023 (top photo below) were not observed in December 2023 (lower photo below), indicating an improvement in condition. However, patches of dead cockles and seagrass, and areas with anoxic sediments at the surface indicated that there had been localised recent impacts from smothering algae.

Mats of *Chaetomorpha ligustica*, Paremata railway flats, January 2023.

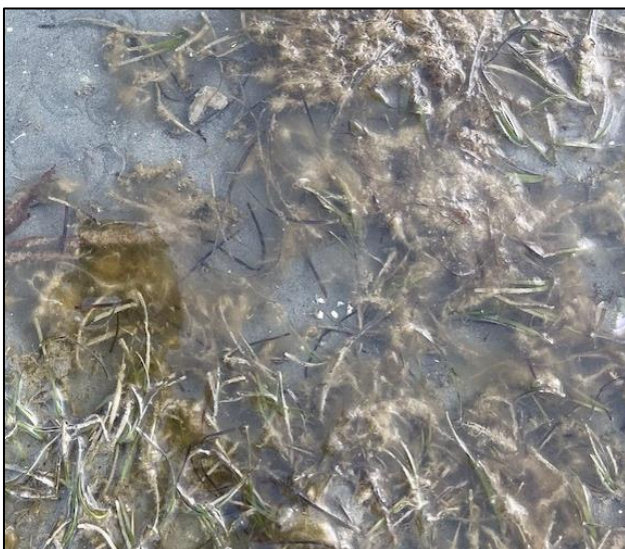
Epiphytic growth on seagrass at Bradeys Bay, December 2023.

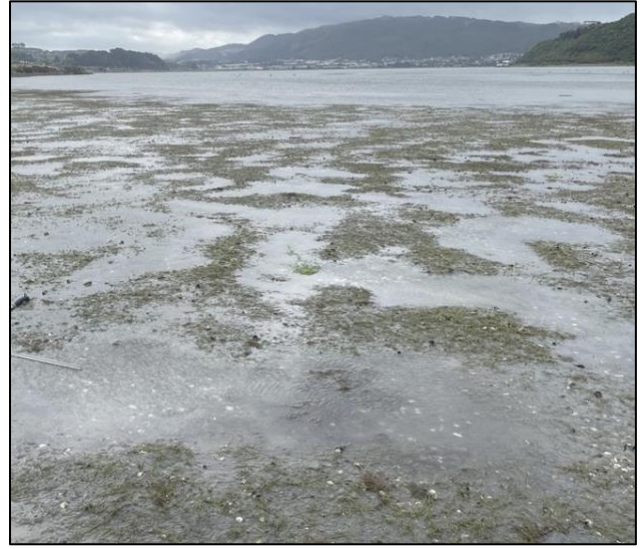
Very little *Chaetomorpha ligustica* was observed on the Paremata railway flats, December 2023.
