Ecological restoration priorities for the Porirua Stream and its catchment

Blaschke and Rutherford Environmental Consultants

**Report for Wellington City Council,
Porirua City Council, and Greater
Wellington Regional Council**

May 2009

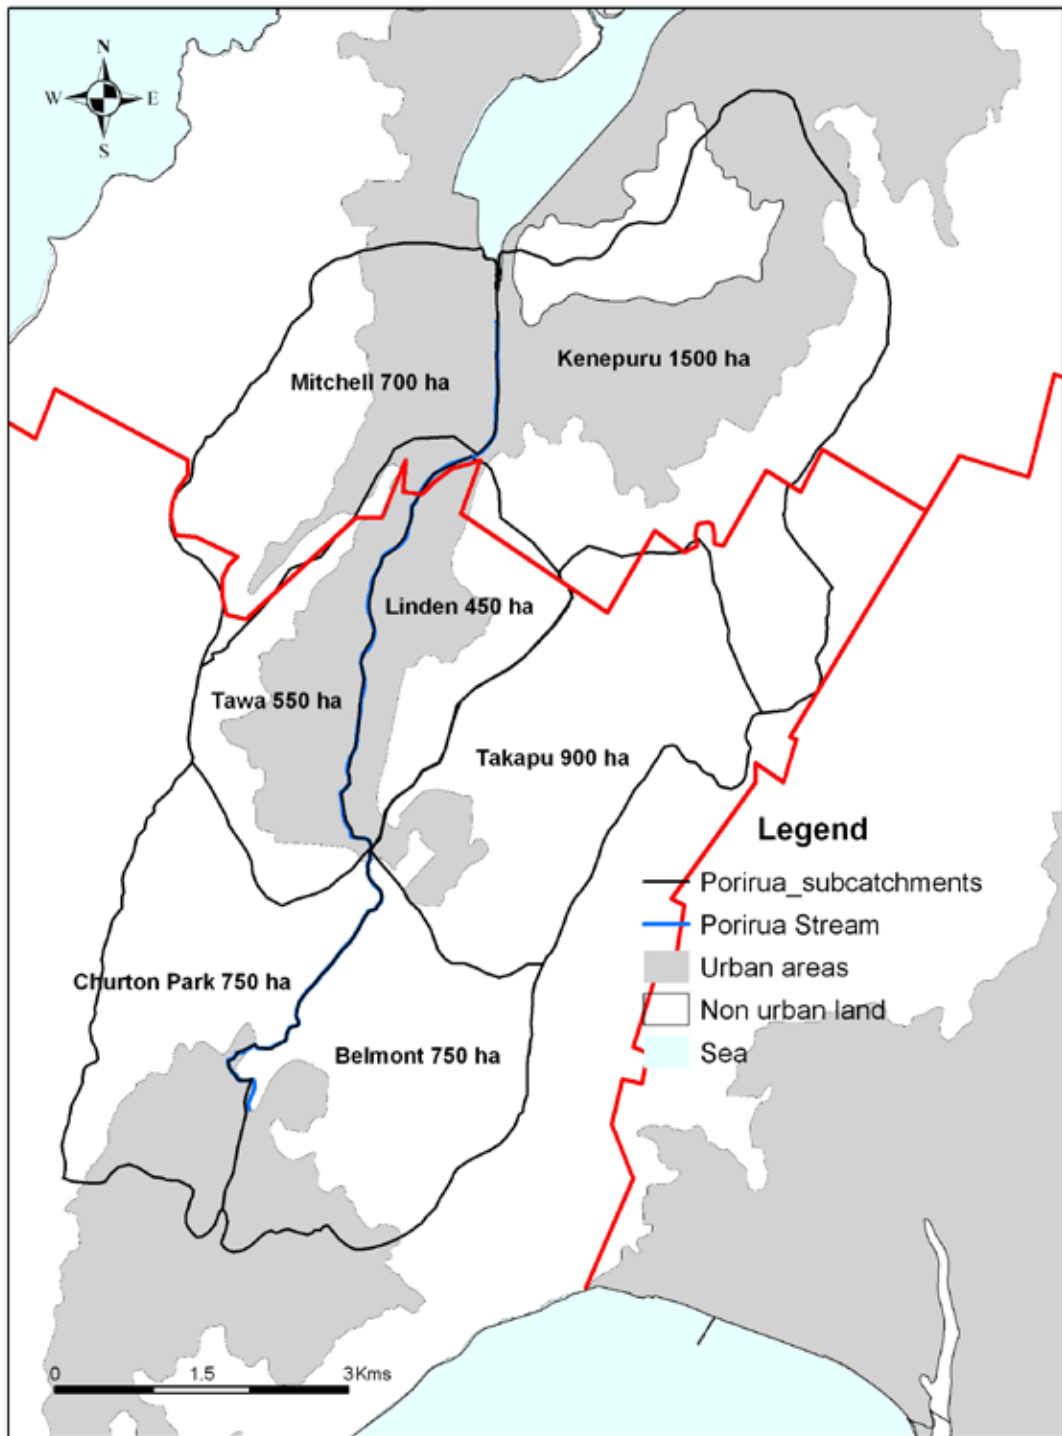
Figure 2: Porirua Stream sub-catchments.

Urban areas are shaded and the Wellington-Porirua city boundary is shown in red.

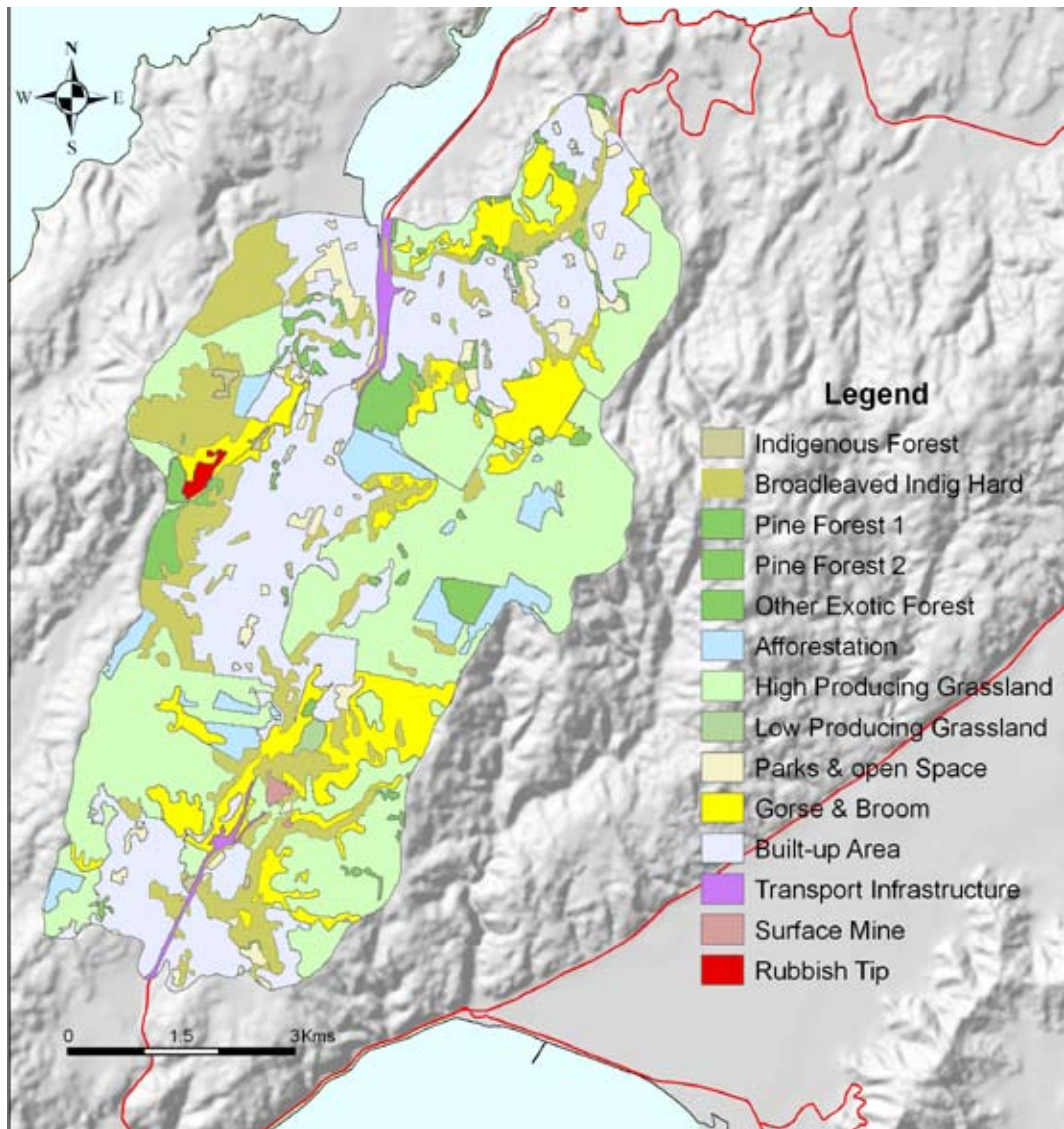
Figure 3: Vegetation and land use in Porirua catchment.

The current land cover (Figure 3 and Table 2) is dominated by pasture and urban areas. Non-urbanised areas other than pasture comprise regenerating forest and scrub (both native and introduced), pine plantations, native forest, and minor disturbed areas such as quarries and landfills. Vegetation and land use differs significantly between sub-catchments. The pattern of public reserves in the catchment can be seen in Fig. 6.

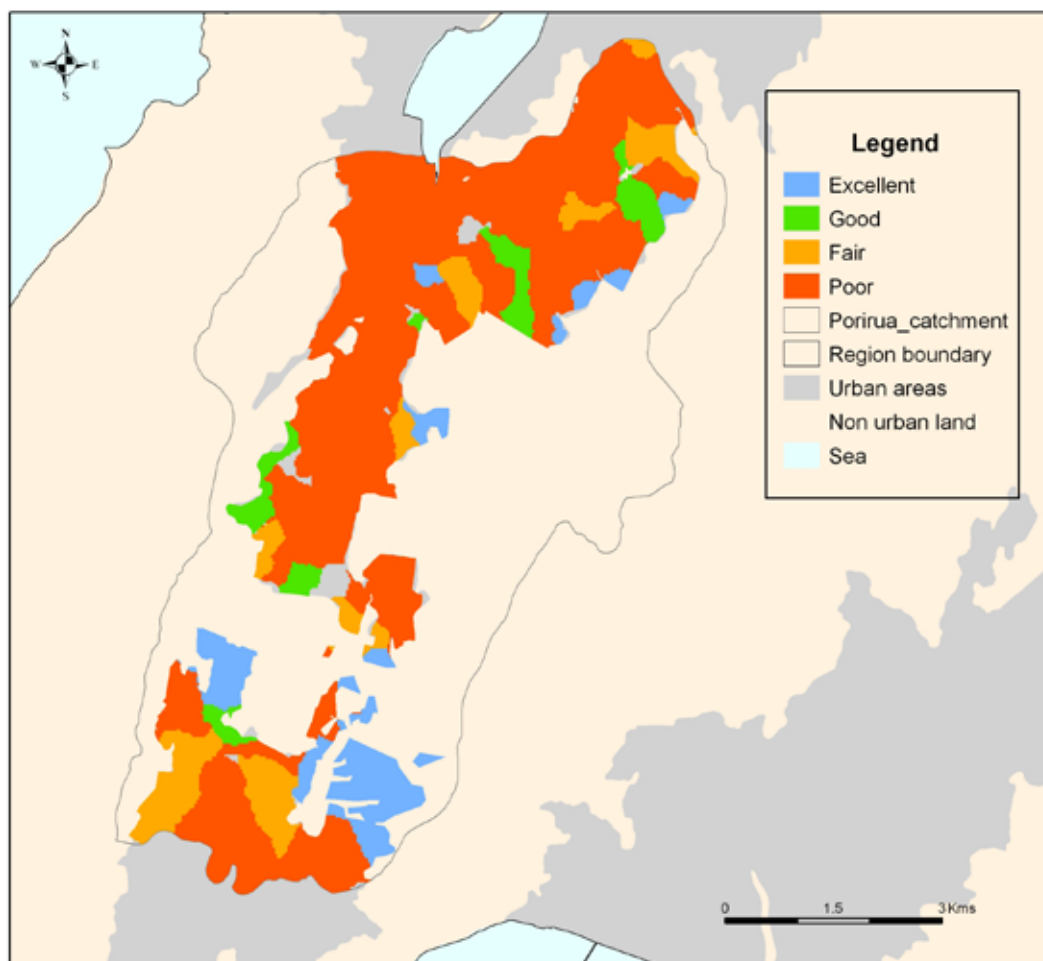
Figure 4: Ecological health in the urbanised parts of Porirua catchment as a function of catchment imperviousness.

In the Wellington region, stream macroinvertebrate health has been found to be inversely correlated with catchment imperviousness (as estimated from roof and road area data). This relationship is currently being used to classify the ecological values of urban streams in the Wellington region. Preliminary work (S Warr, GWRC, pers comm. April 2009) has identified thresholds for the relationship between macroinvertebrate community health in urban streams and impervious cover in the surrounding catchment. Figure 4 shows what this looks like for the urbanised parts of Porirua catchment. Further work is being undertaken to integrate native fish values into the classification.

Excellent = 1-5% imperviousness, Good = 5-15%, Fair = 15-20% or Poor = 20-100%.

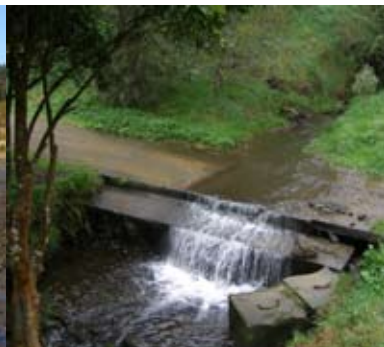
Stream crossing of Mitchell Stream at Park constitutes a significant fish barrier

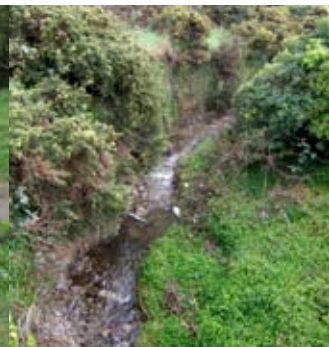
Weed-infested banks of lower Mitchell Stream

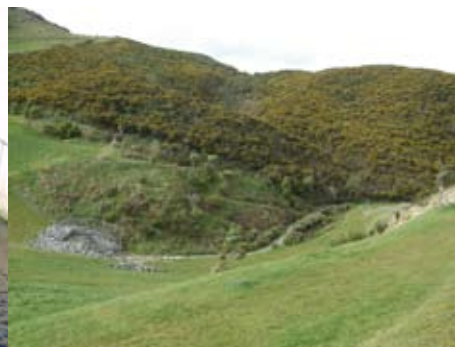
Stebbings Stream discharge from Stebbings Dam

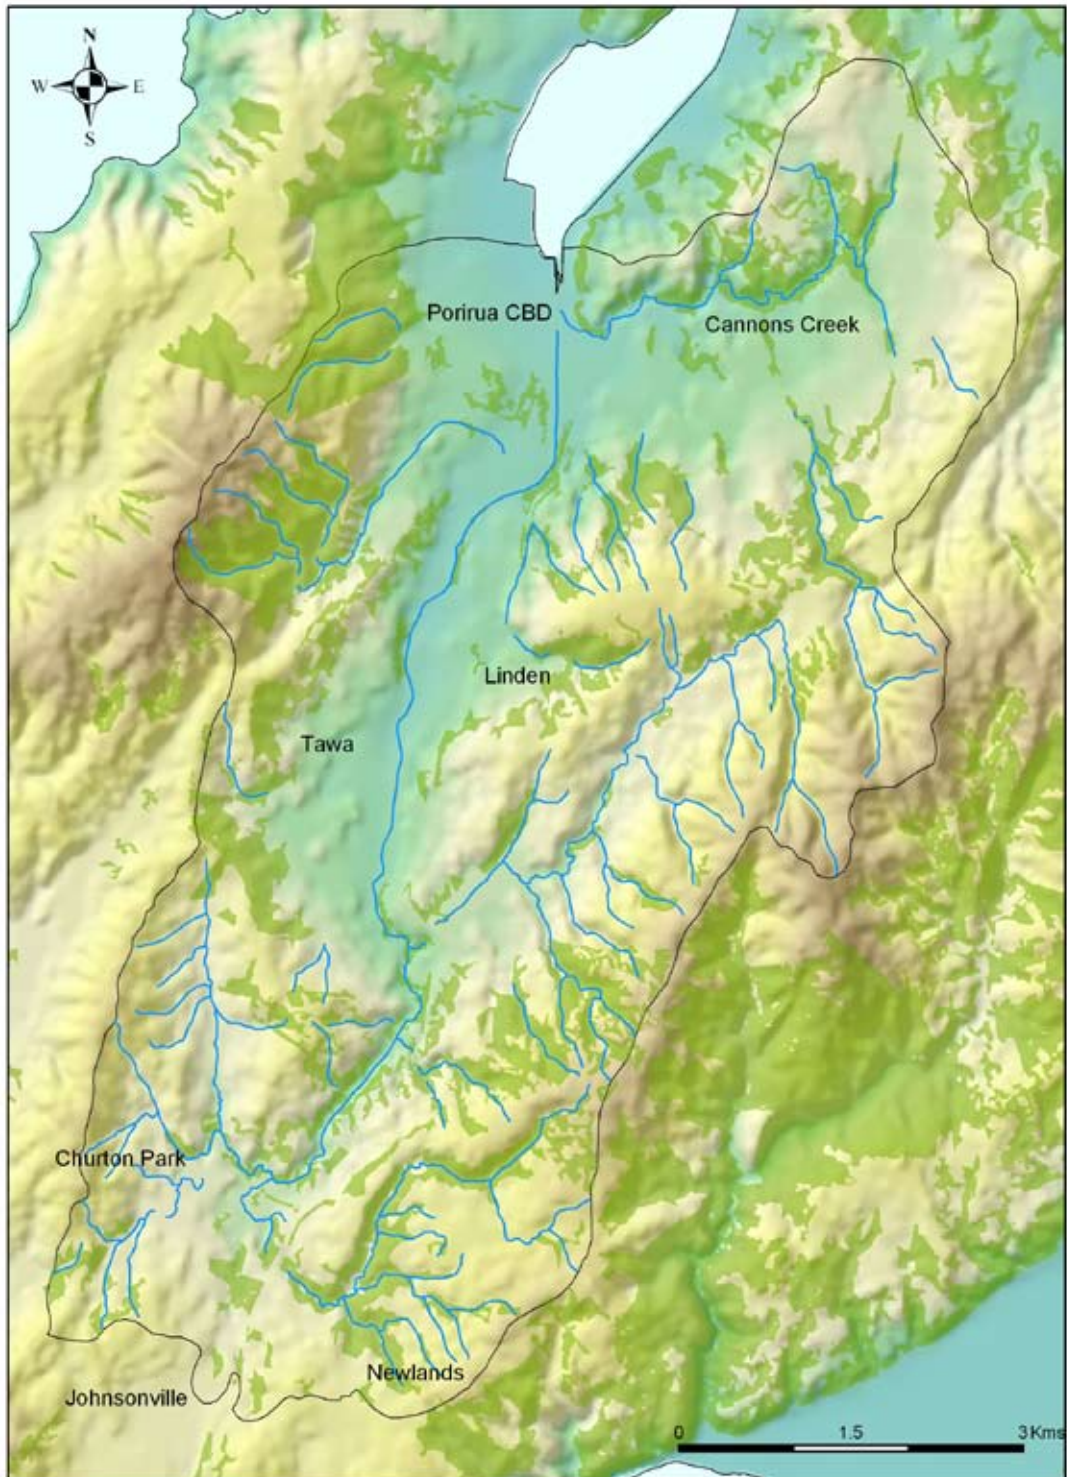
Figure 5: A natural framework of significant indigenous vegetation, streams and topography in Porirua catchment.

A natural features framework based around topography, streams and native vegetation is shown in Figure 5. Note that several sub-catchments currently lack significant vegetation in riparian areas, and that breaks in the stream system in Figure 5 indicate significant lengths where streams are culverted.

Topography is shaded from aqua (lowland and basins) through to brown (hill summits). Significant native vegetation is apple green. Streams are in blue; breaks in streams show piped or hard-lined sections.

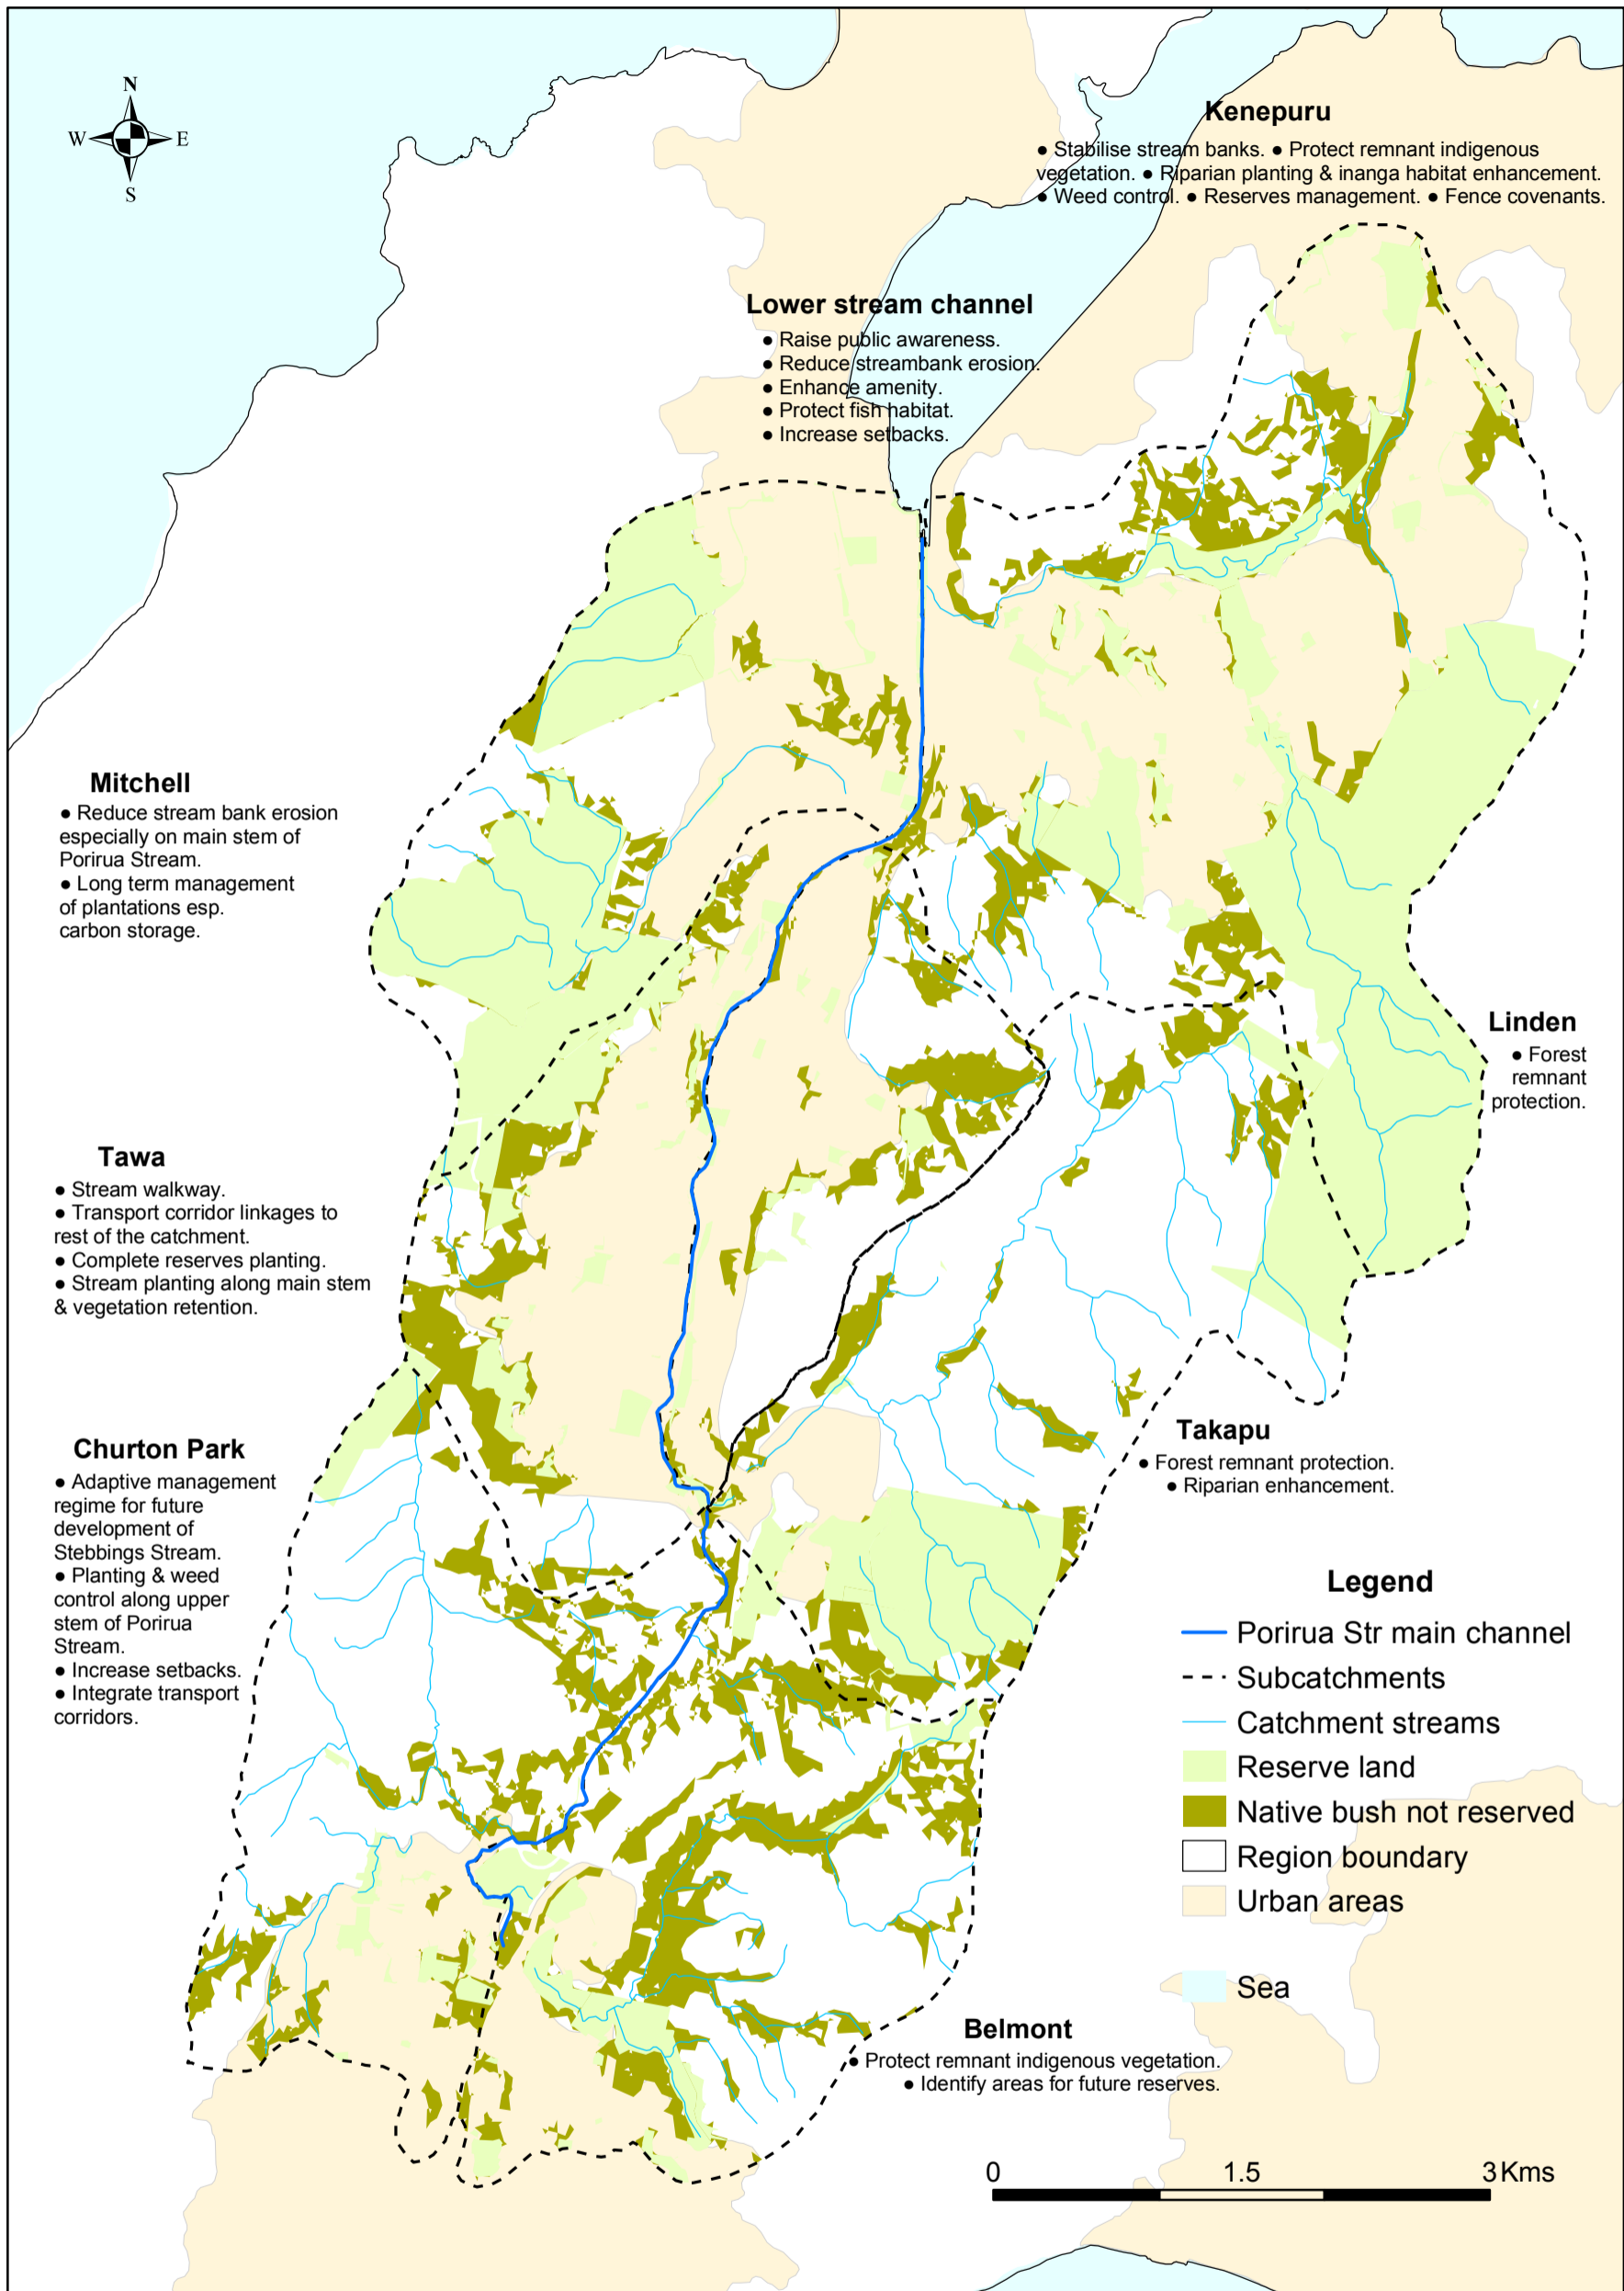
Figure 7: Porirua catchment restoration priorities, by sub-catchment (A3 inset)

Sub-catchment	Area (ha)	Priority recommendations & opportunities (short to medium term)
Kenepuru	1500	Reserves management, plan future reserves contributions. Enhance inanga habitat in lowest of reaches of Kenepuru Stream. In Belmont Regional Park, complete fencing covenant areas and identify other areas with high biodiversity values. Weed control and riparian enhancement in Bothamley Park. Fence covenanted areas in Belmont Regional Park.
Linden	450	Ecological linkages between transport corridor and rest of sub-catchment.
Takapu	900	Stream stability, vegetation retention & protection. Riparian enhancement on Takapu Stream, fence stock out of stream.
Belmont	750	Vegetation retention & protection, plan future reserves contributions. Include rail and motorway land in restoration plans for Glenside Reserve
Churton Park	750	Set aside and plant riparian land currently in pasture. Vegetation retention & protection, plan future reserves contributions. Active adaptive management approach to development and enhancement of the Stebbings Stream and catchment, including any planned road connections, with careful monitoring of biodiversity and water quality trends.

Tawa	550	Complete reserves planting, especially adjoining main stem. Assist planting the proposed walkway/ cycleway. Vegetation retention & protection, plan future reserves contributions. Investigate long-term opportunities for plantation forest areas, including carbon storage.
Mitchell	700	Reduce stream bank erosion, especially Spicer Road reach. Investigate lake in Colonial Knob Scenic Reserve. Investigate long-term opportunities for plantation forest areas including carbon storage. Manage structures for fish passage and apply adequate setbacks in hospital reach.
Upper channel	–	Planting and weeding riparian land and transport/rail corridor, development setbacks
Lower channel	–	Raise public awareness & access, reduce erosion, increase amenity values. Support ecological aspects of cycle/walkway project and extend to estuary, protect fish habitat, plant transport/rail corridor and estuary, development setbacks. Joint council/ community project for floodway enhancement/ maintenance, focussing of stream estuary area (council and OnTrack land).

In this final section we set out our key recommendations for priority restoration actions in the Porirua Stream and its catchment. There are two groups of recommended actions: the first that are generic to the whole catchment, and the second that are more site-specific (sub-catchment or reach). Priority actions (i.e. recommended within the next two years) that are location-specific are shown in Figure 7.

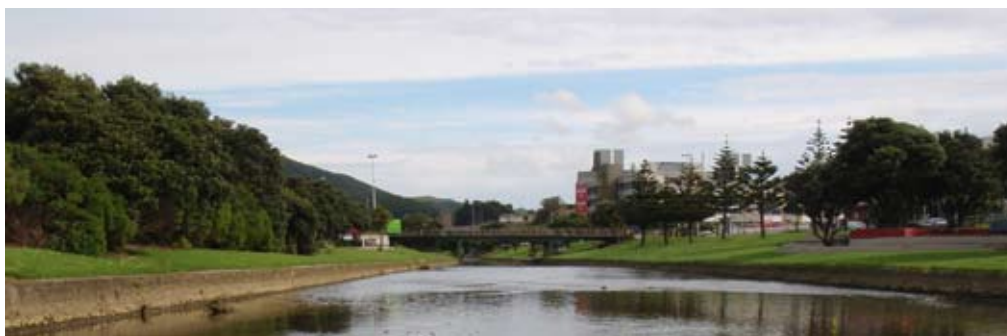
Case study 1: Managing floodways and protecting biodiversity

Flooding in Porirua catchment has been managed by instigating a number of measures. Flood flows are attenuated (held back) by flood protection detention structures which hold some of the water from rainfall events back in the upper catchment, easing flows in the main stem of the stream. These measures, plus planning rules requiring development to be set back from the stream (see Case Study 2), and streambank protection work and vegetation management in the lower stream, are all designed to protect the Porirua CBD from flooding. The measures keep stormwaters in the channel and direct them into the harbour promptly without risk of blockage.

One of these measures is that some of the Porirua floodway is maintained by mowing a wide grass strip alongside the stream. Access to the grass for a tractor-drawn reach mower is difficult owing to the historic placement of buildings and other structures close to the stream. As a result, some of the grass is mown by driving the tractor along the streambed, in the water, while the mower reaches up the bank. There is also an area of streamside blackberry infestation which has to be cut back annually from the waterway, again using machinery in the stream. This maintenance regime causes considerable disturbance and damage to the bed of the stream, the waterway and the fish and insects that inhabit these areas.

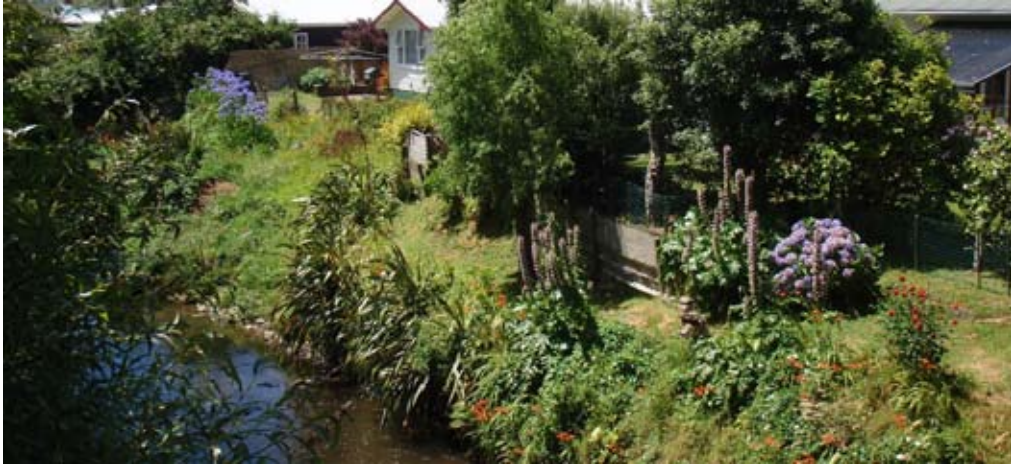
Case study 2: Stream setbacks: working within the rules of multiple agencies

Development of the land at the margin of Porirua Stream is a continuing process. However, recent consent applications have resulted in ongoing discussions between councils on the required width of setbacks from the stream edge. At issue is a lack of consistency between territorial authority rules, and the application of those rules with regard to: onsite sediment control, access to and maintenance of the watercourse, downstream erosion and sedimentation effects, and ecosystem function.

A retirement village development was recently planned for Tawa. WCC District Plan rules require a 5 metre setback on the selected site as it is in a designated floodway. GWRC Flood Protection Department (GWFP) asked for the setback to be increased to 7 metres. GWFP was concerned that active stream movement and the actions of the watercourse would erode the high streambanks, making it unsafe to carry out stream maintenance within a narrower setback. GWFP also felt that there was a potential for structural works to be necessary to allow continued maintenance of this section of Porirua Stream. There were also concerns about adverse effects of erosion followed by structural work, on stream water quality and ecosystem function. GWFP has made similar requests for other developments in this area.
