### **Request for information 2023-202**

# Pilot study: indoor air quality monitoring on Metlink buses

GW/ESCI-T-23-6

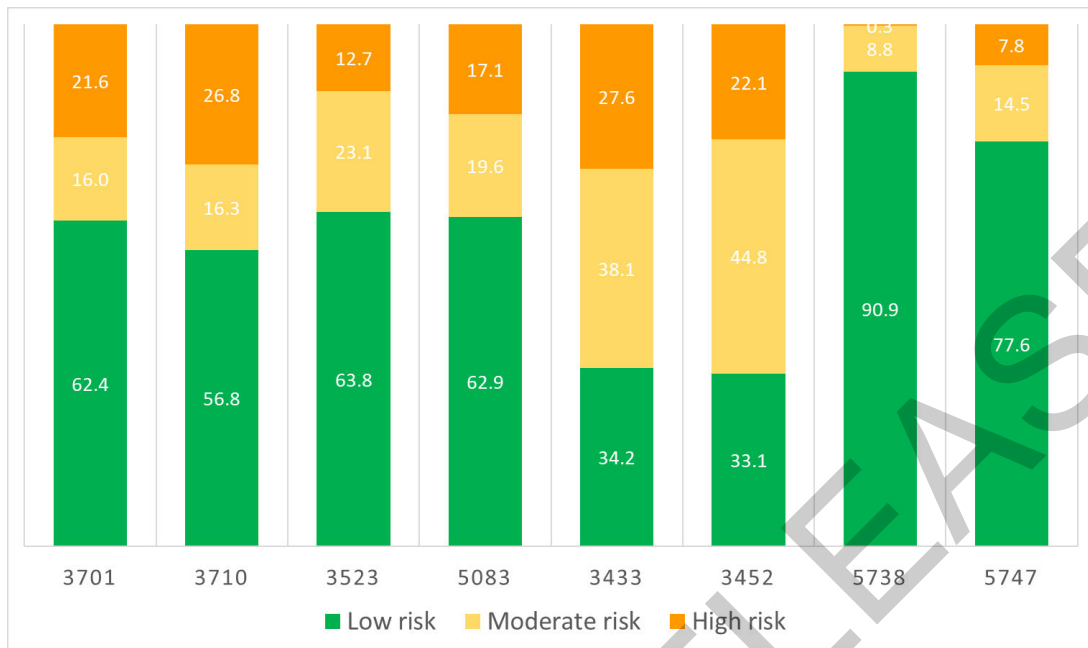
**Figure 4.1: Percentage of time all CO<sub>2</sub> ppm (30 second averages) were in OzSAGE risk of viral transmission categories by vehicle tested. Includes rest breaks and bus repositioning. Low risk = < 800 ppm, Moderate risk = > 800 and < 1500 ppm, High risk = > 1500 ppm**

Figure 4.1 shows the percentage of time monitored CO<sub>2</sub> levels (as a 30-second average) occurred in the OzSAGE relative risk banding levels for each vehicle monitored, including rest breaks and repositioning. Poor ventilation conditions, indicated by CO<sub>2</sub> above 1500 ppm, ranged from 0.3% of the time (Bus 5738) to 28% of the time (Bus 3433).

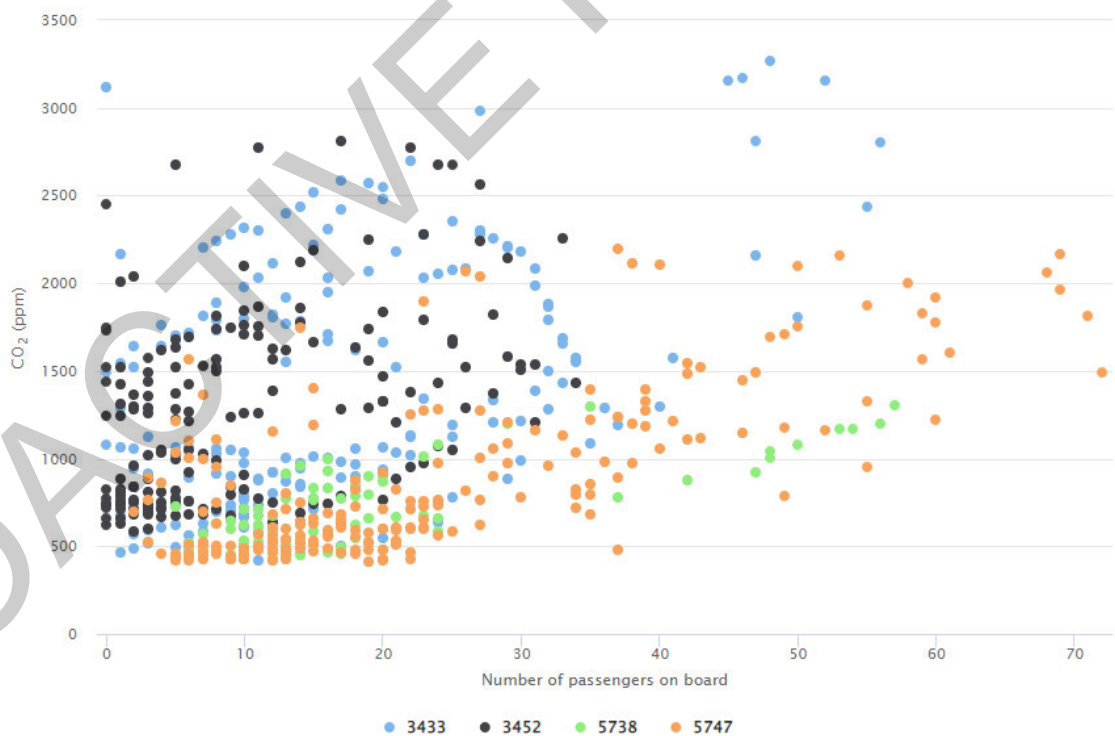
**Figure 4.2: Single deck buses. Average CO<sub>2</sub> ppm vs number of passengers on board between bus stops by vehicle ID.**

Figure 4.2 shows that on single deck buses average CO<sub>2</sub> levels above 1500 ppm between stops were found across the range of passenger numbers (0 to 72) except for bus 5738. Figure 4.3 shows at times high CO<sub>2</sub> concentrations between stops on the upper decks across the entire range of passenger numbers. The highest upper deck CO<sub>2</sub> concentrations were found on the two electric double decker buses (3701 and 3710). Although it was not possible to identify the split between passenger numbers on the upper and lower levels, the higher CO<sub>2</sub> concentrations found upstairs were probably due to the smaller upstairs cabin volume and slower decay rate of CO<sub>2</sub> (emitted by previous passenger) as there was less fresh air introduced upstairs compared to downstairs when bus doors open for passengers to board and disembark.

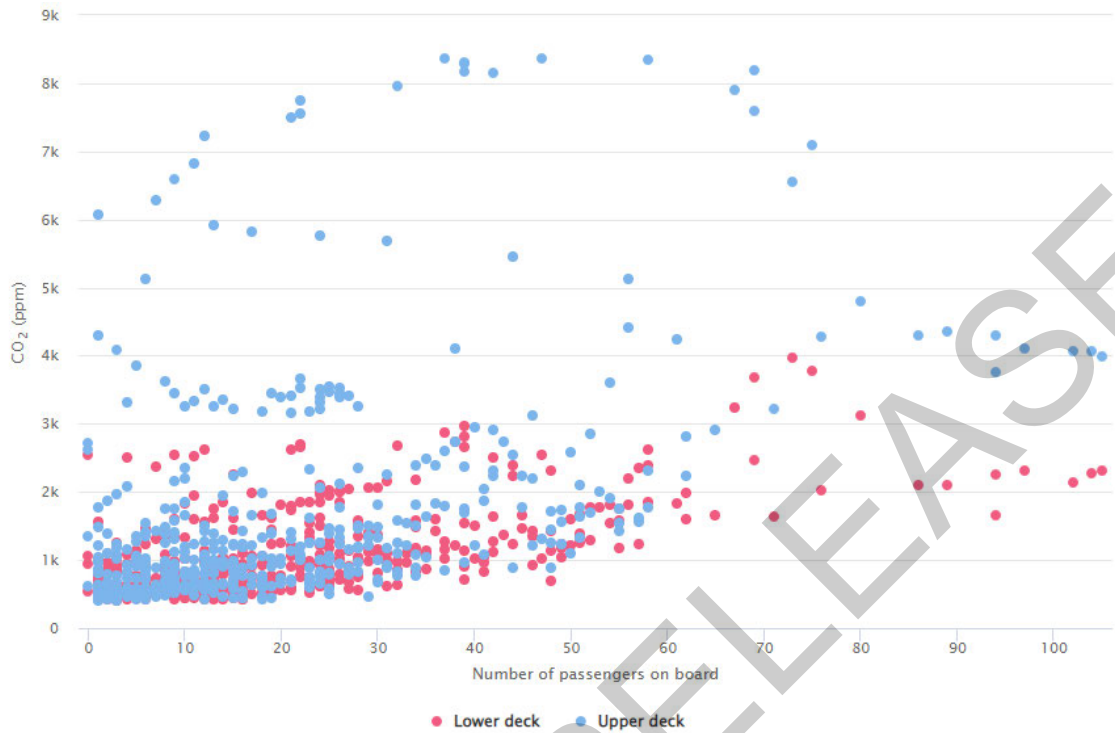
**Figure 4.3: Double decker buses. Average CO<sub>2</sub> ppm vs number of passengers on board between bus stops by upper and lower deck.**

Passenger numbers onboard between bus stops were estimated using the difference between number of passengers alighting and passengers disembarking as recorded by snapper and gold card data. Although, in general CO<sub>2</sub> peaks temporally coincided with peaks in passenger numbers (Air Matters Ltd Appendix B: CO<sub>2</sub> time series graphs), there was considerable variability in the relationship between CO<sub>2</sub> and passenger numbers. Passenger numbers onboard and average CO<sub>2</sub> levels between each stop are shown for single deck buses (Figure 4.2) and by deck for double decker buses (Figure 4.3).

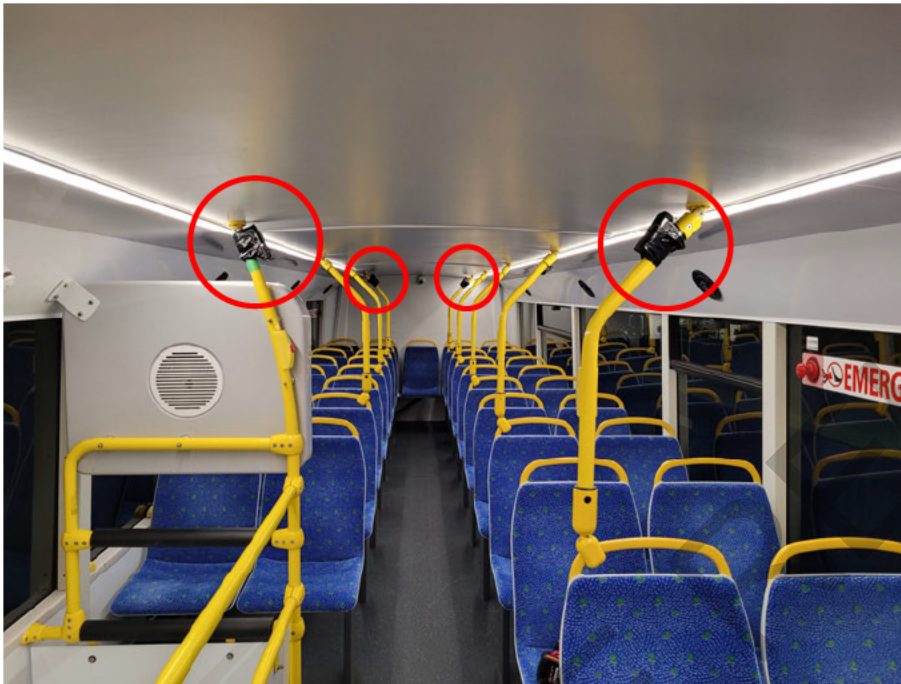
Figure 1. Example of the monitoring installation (red circles) in upper level of Bus 3701.

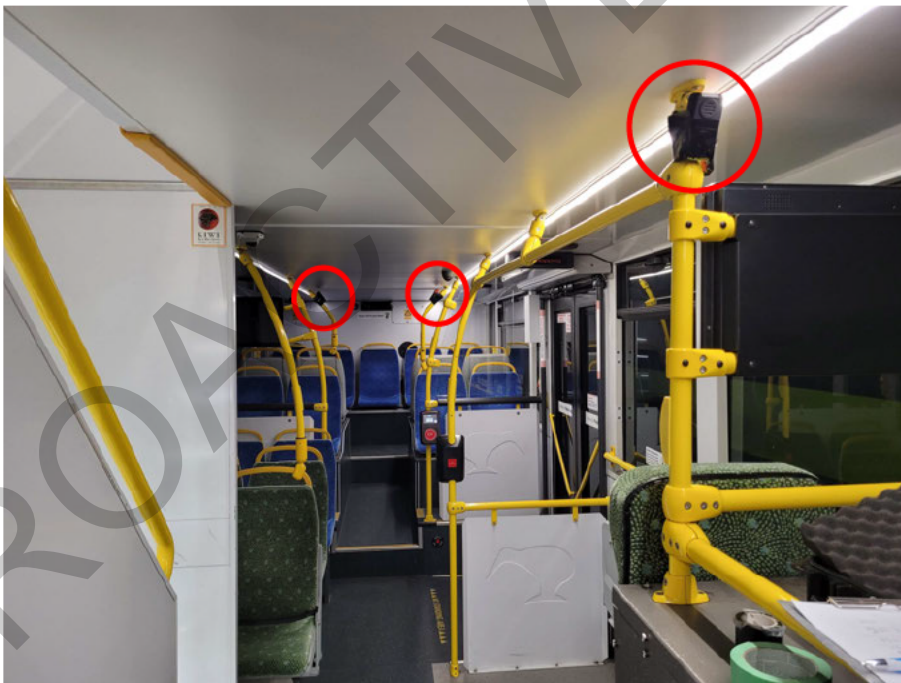
Figure 2. Example of the monitoring installation (red circles) in lower level of Bus 3701. Note on double decker buses the mid monitors were located back-to-back due to the location of the stairwell.

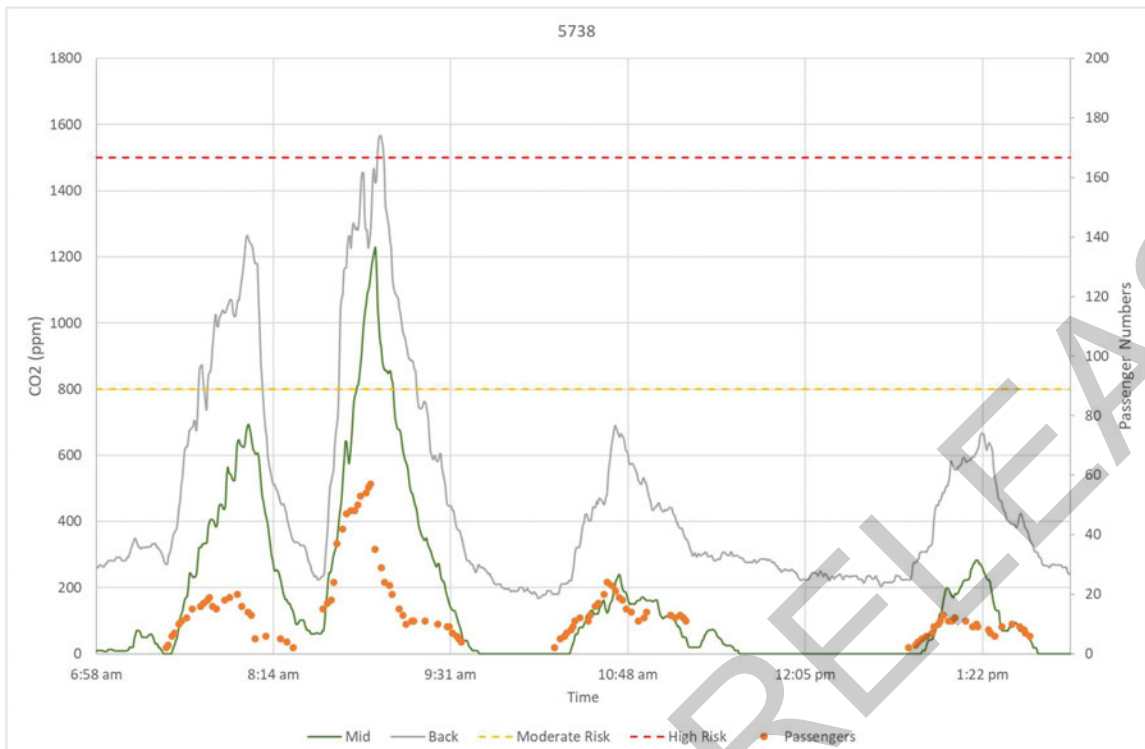
**Figure 3. Bus 5738. Electric monitored on 18 October 2022. Note the Mid monitor's potential drift recording CO<sub>2</sub> concentrations of zero at times.**

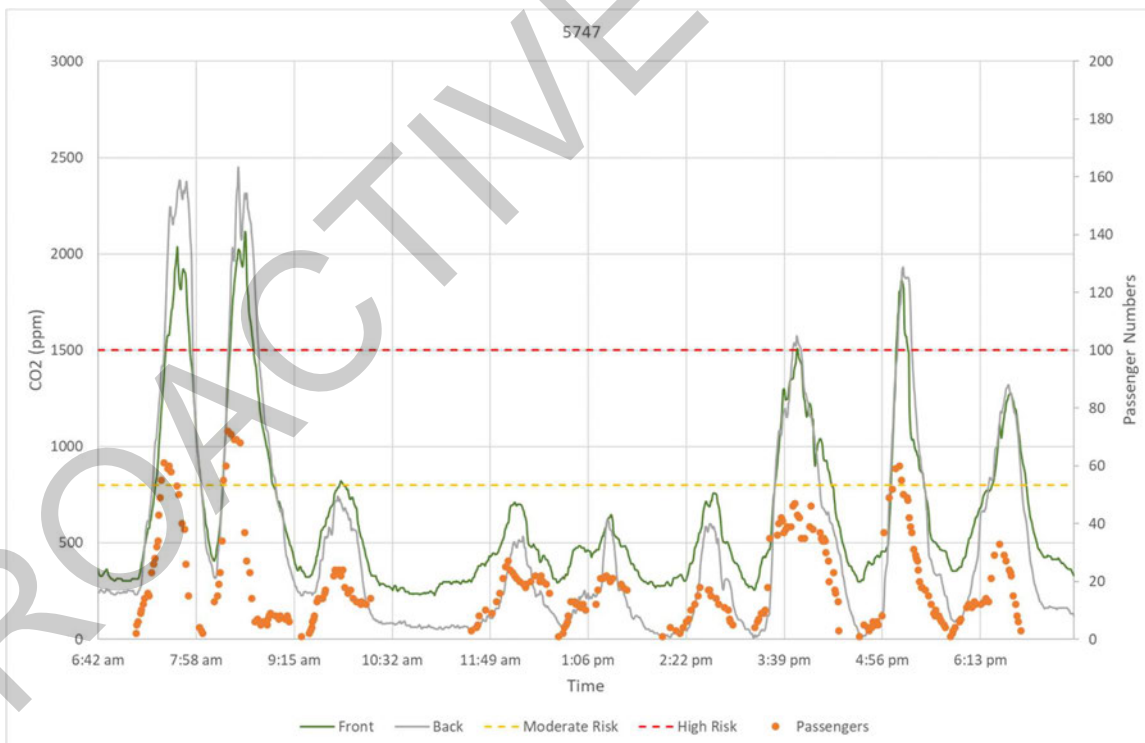
**Figure 4. Bus 5747. Electric monitored on 18 October 2022.**

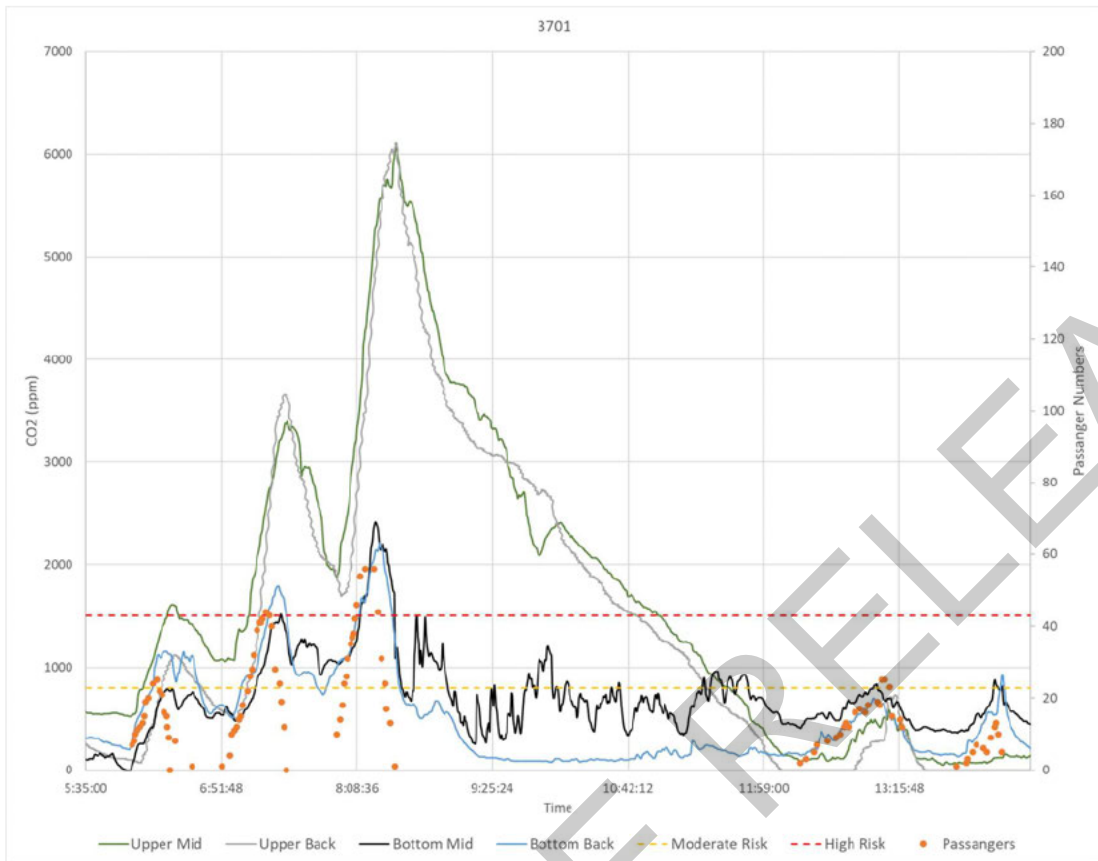
**Figure 5. Bus 3701. Electric double decker monitored on 20 October 2022. Note the Upper Back monitor's potential drift recording CO<sub>2</sub> concentrations of zero at times.**

Bus 3701 and 3710 showed the most significant difference between the upper and lower levels with the lower level having notably lower concentrations of CO<sub>2</sub> (refer Appendix A: Figure 5 and 6). This contrasts with the two other double decker buses (3523 and 5083) which showed a much closer correlation between upper and lower levels (refer Appendix A: Figure 7 and 8). This may have been caused by variation in passenger numbers between the levels however this information was not recorded.

The data illustrates that CO<sub>2</sub> concentrations rise quickly with the influx of passengers but in most cases takes an extended period of time to dissipate back to ambient concentrations. For example, on Bus 3701 after all passengers have disembarked post morning peak the CO<sub>2</sub> concentration in the upper level takes over 180 minutes to return to below 800ppm. No information on the bus's status (running / air conditioning) is recorded to understand this better, and it has also been identified that some passenger loading information is missing from the supplied record.

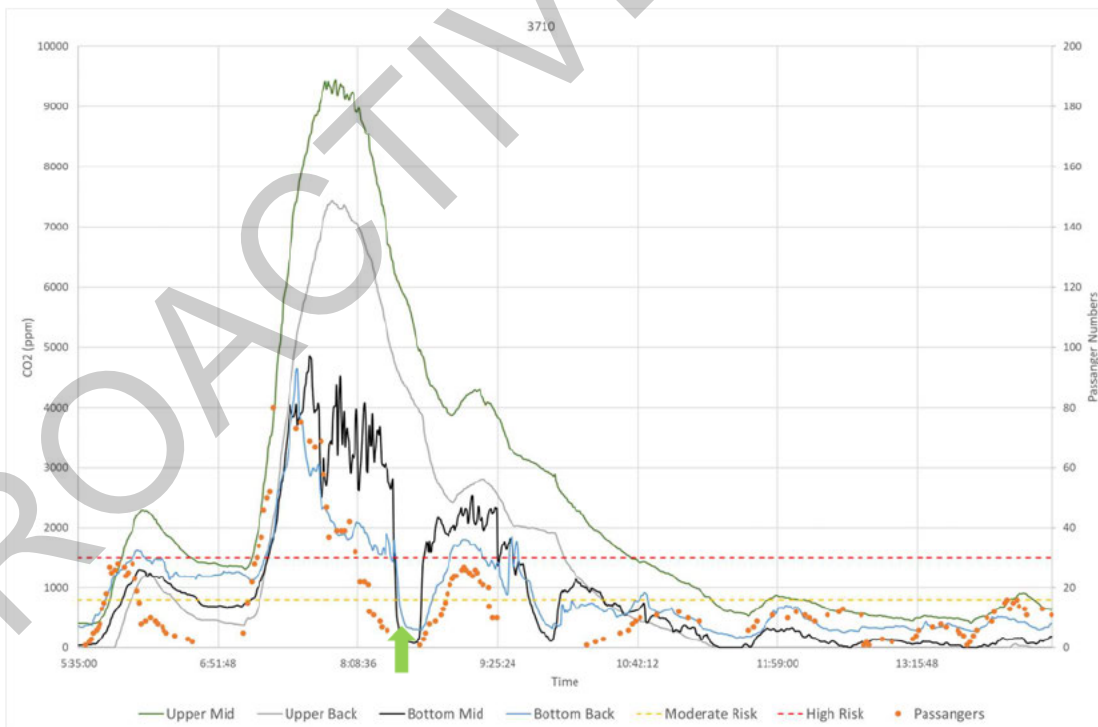
**Figure 6. Bus 3710. Electric double decker monitored on 20 October 2022. Note Bottom Mid and Upper Back monitor's potential drift recording CO<sub>2</sub> concentrations of zero at times.**

The author was on board 3710 throughout the morning peak and observed that the bus was at capacity (fully seated in the upper level and seated / standing in the lower level). Concentrations on the lower level may have been reduced due to improved ventilation and/or fresh air ingress from door openings. Bus 3701 was also fitted with manually opening windows, so it is possible that passengers on the lower level had opened one or more windows allowing better circulation of fresh air.

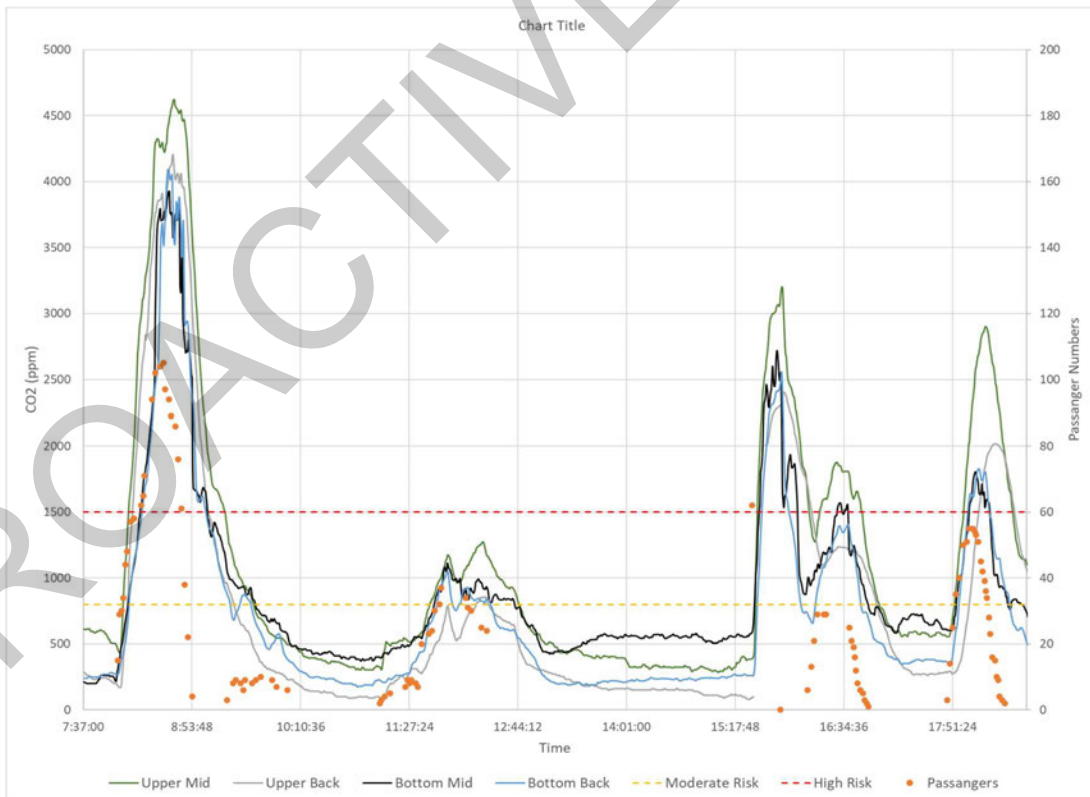
**Figure 8. Bus 5083. Diesel double decker monitored on 18 October 2022. Note the gap in Upper Back CO<sub>2</sub> record from 15:31 – 15:39 when it is expected that the monitor was tampered with.**
